the **play** inspection company

Annual Inspection

Creech St Michael

Creech St Michael Junior Area

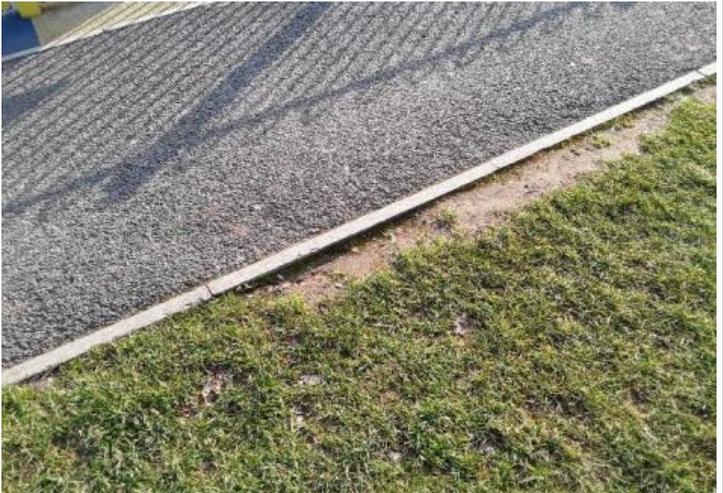
8 - Low Risk (Finding 1)			
Item:	Ancillary Items - Site General	Risk Level:	L - Low Risk
Manufacturer:	Owner/Operator	Surface:	N/A

Finding: There are trip hazards at the edges of the footpath surface		Action: Reinstate surrounding surface levels to remove the trip points

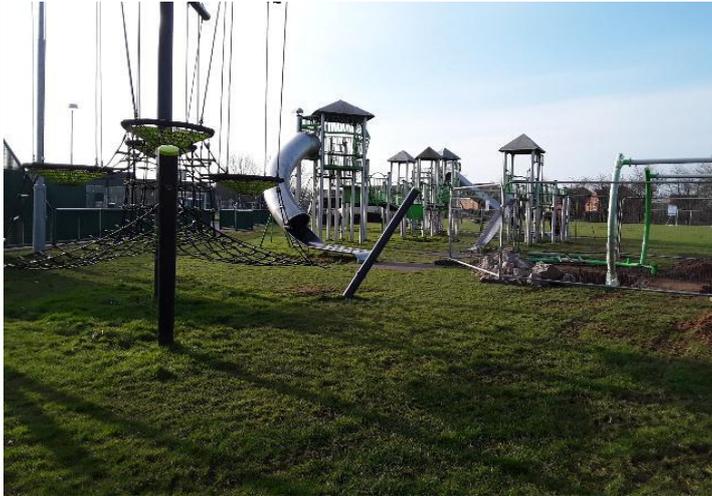
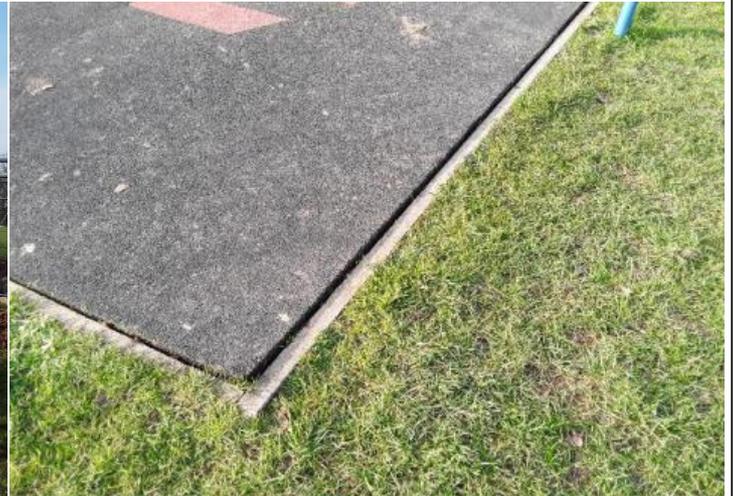
i 8 - Low Risk (Finding 2)

Finding: The surface is lifting at the edges and creating trip points
Action: Repair perimeter of surfacing to remove trip points

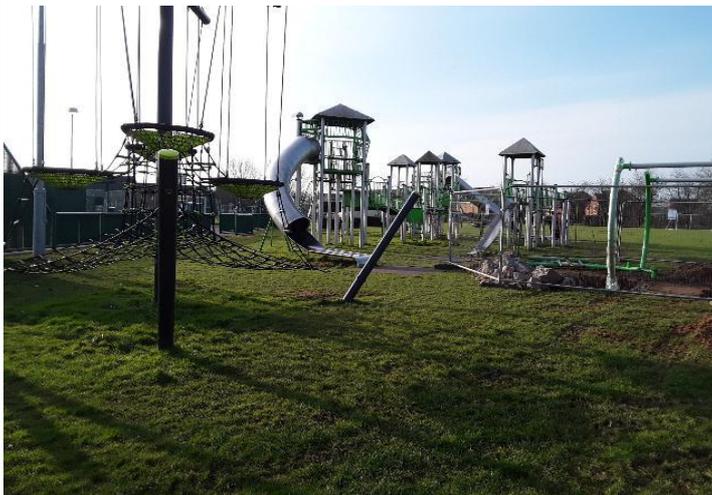
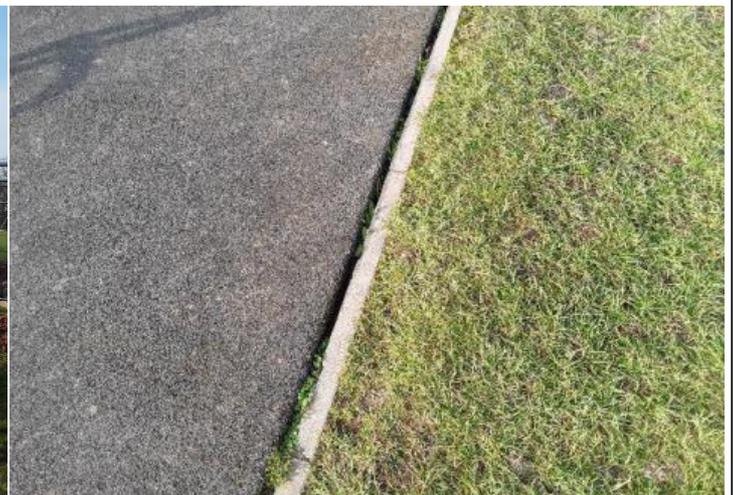
i 9 - Low Risk (Finding 3)

Finding: There are significant gaps (over 30mm) between the surface and the edging or between the joints in the surface; these are large enough for a small foot to enter
Action: Repair surfacing

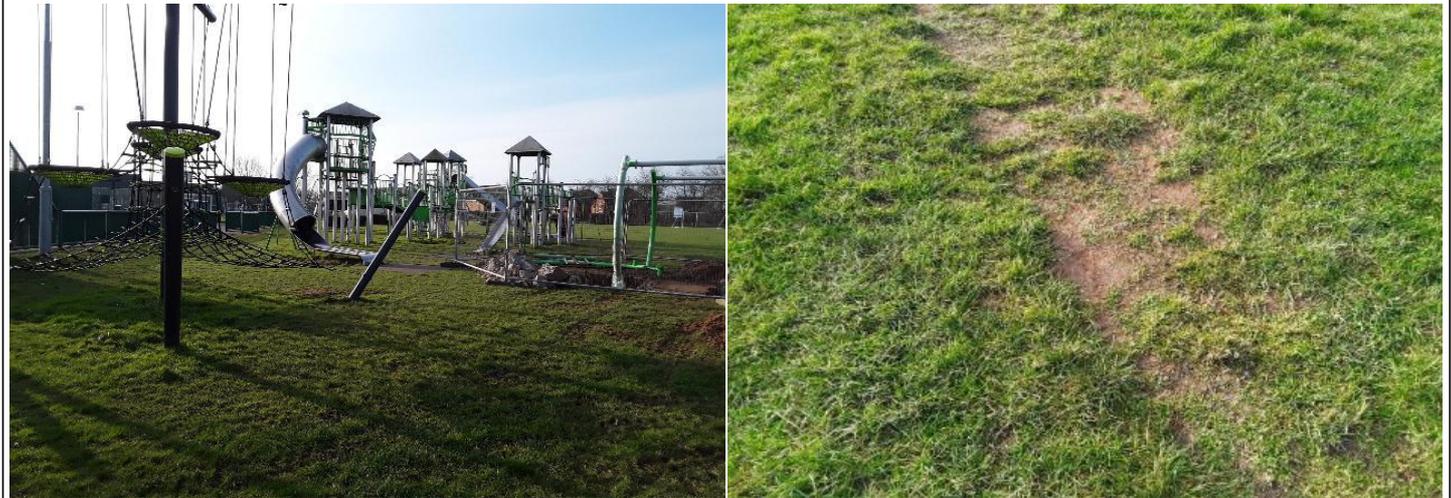
8 - Low Risk (Finding 4)

Finding: The grass mats are silted up and the soil is compacted; this may have an effect on the impact absorbing properties of the surface
Action: Consider HIC testing impact absorbing properties to ensure the correct surface qualities are maintained for the equipment and replace as required

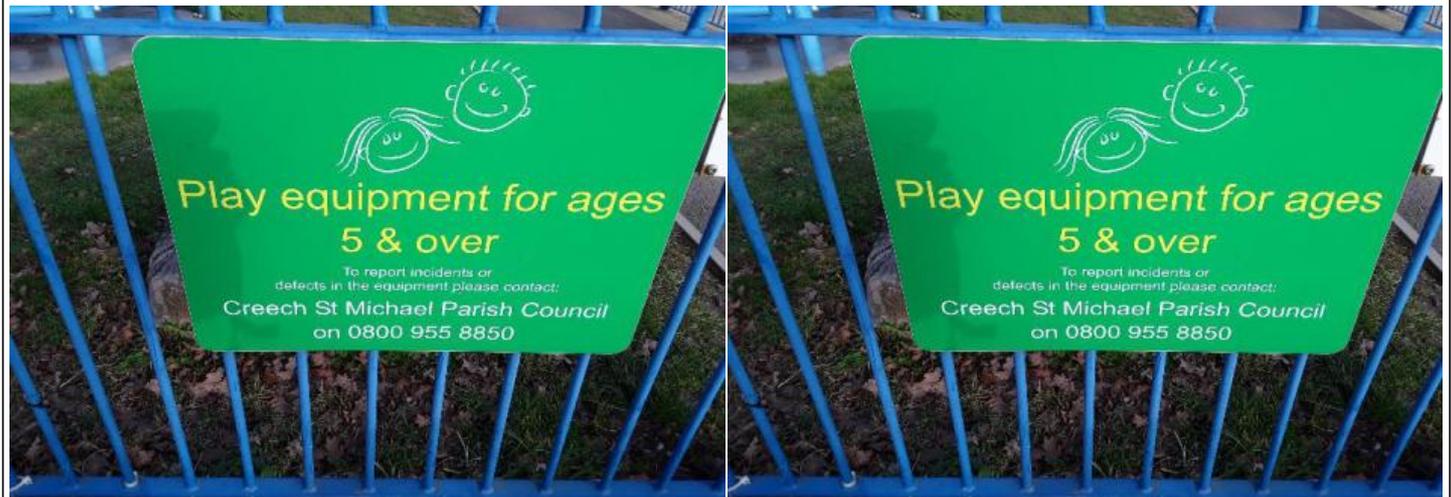
5 - Very Low Risk (Finding 1)

Finding: BS EN 1176 Part 7 recommends that signage shall include the site name / address
Action: Provide additional information

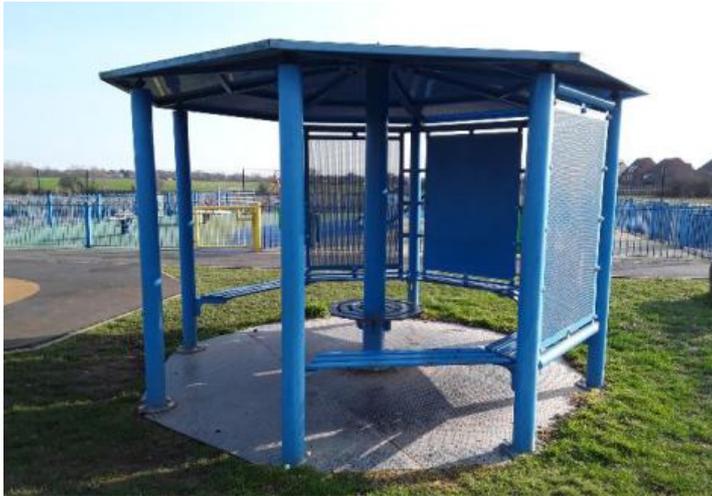
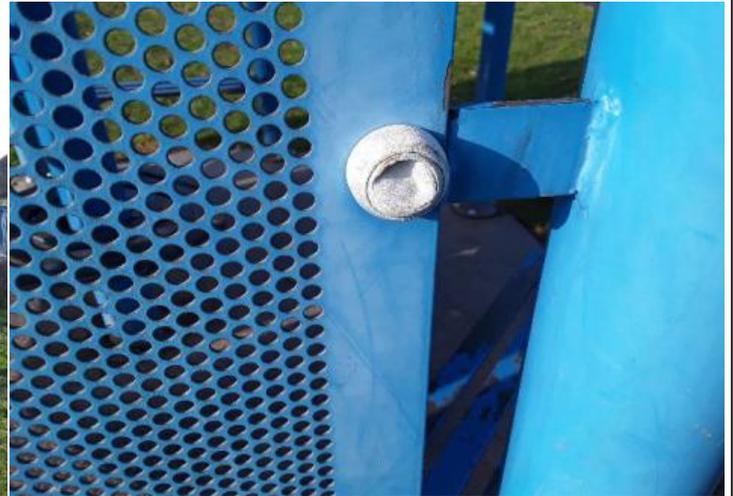
Finding: There is/are bolt cap covers missing or damaged on the item

Action: Replace missing or damaged bolt cap covers

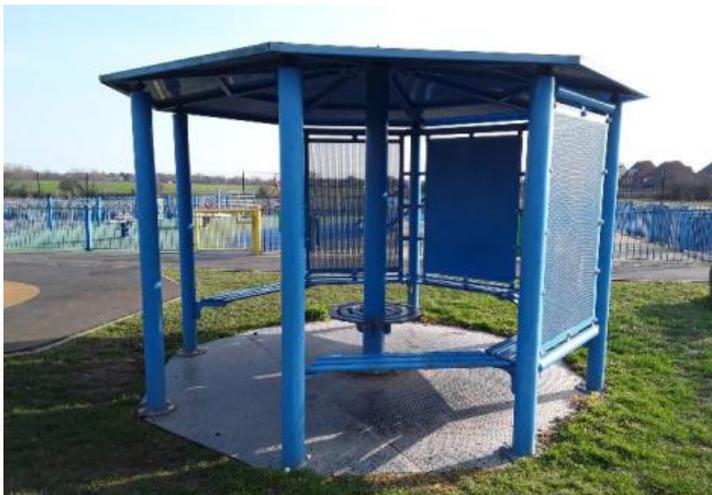
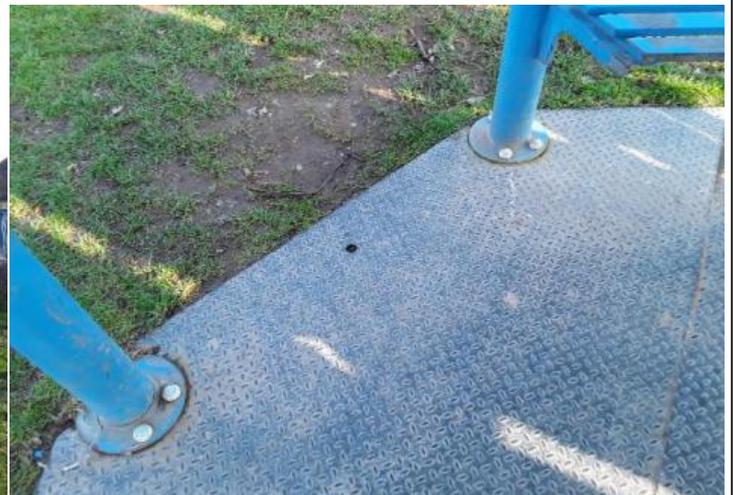
Finding: There are trip hazards present over the shelter base

Action: Reinstate surrounding surfaces to level to remove the trip points

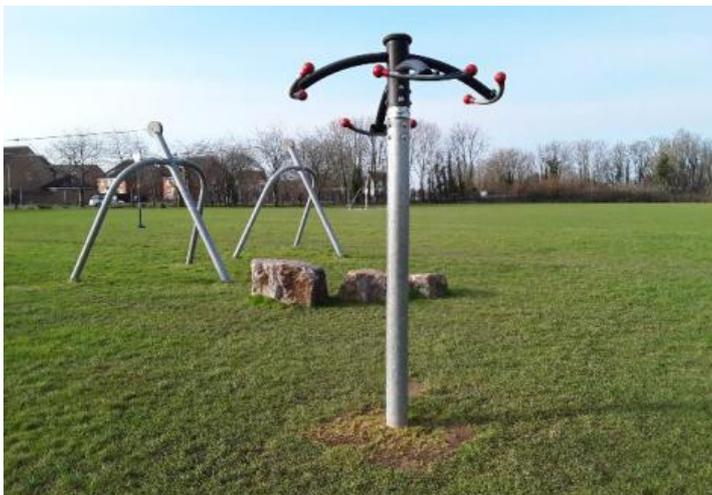
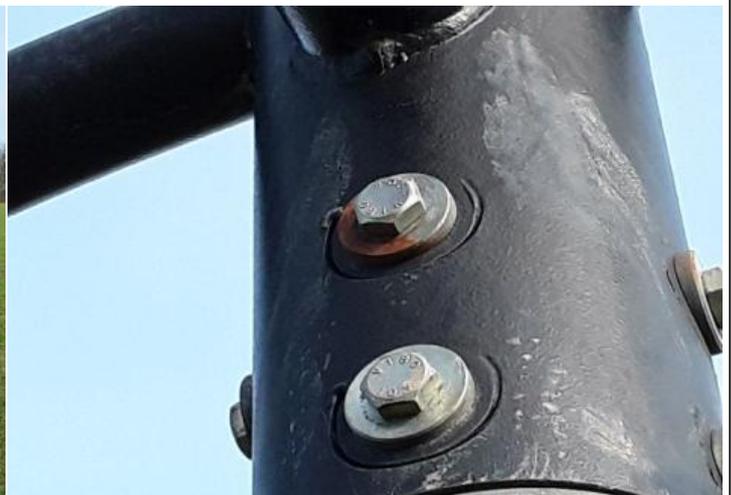
Finding: There is surface corrosion present on the item
Action: Consider treating the item

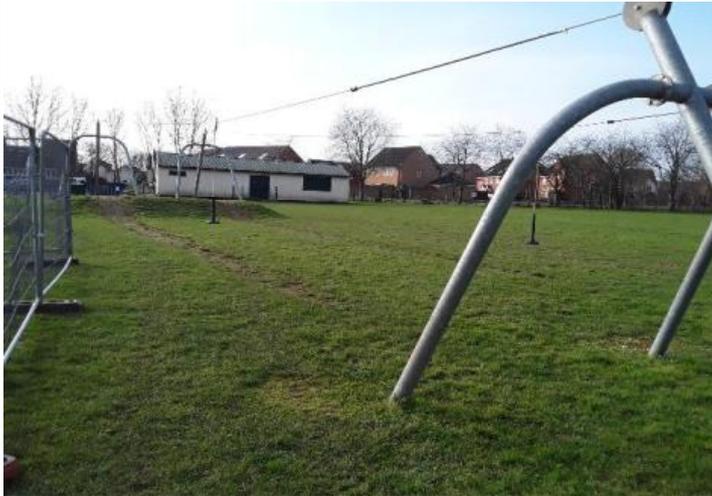
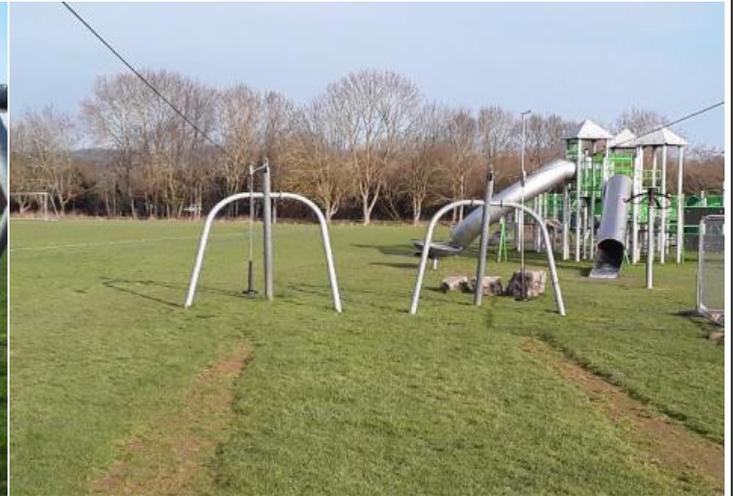
i 0 - Risk Assessment not Undertaken (Finding 1)

Finding: We have completed a visual inspection of the suspension links, cable and fixing points from ground level, however it is not possible to fully inspect these areas without either hiring equipment to gain access or removing the cable and suspension and inspecting at ground level. We recommend that the main cable and fixing security is thoroughly inspected at least in accordance with the manufacturers recommendations to check for wear, damage, security or internal rusting; this will help to ensure the continued safe use of the equipment

Action: Inspect in accordance with the manufacturers recommendations

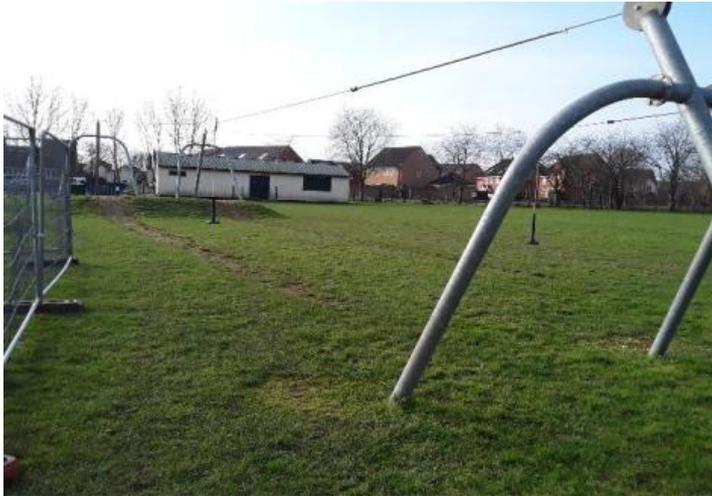
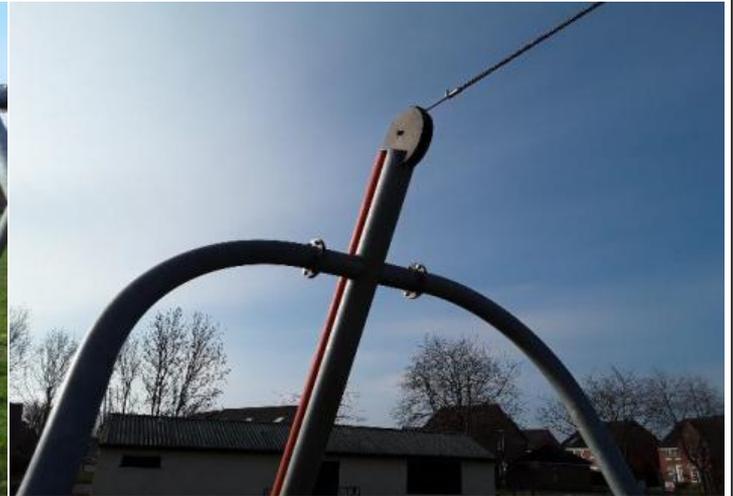
i 0 - Risk Assessment not Undertaken (Finding 2)

Finding: The fixings or components for this item were in excess of 2.5m above the standing surface and could not be fully accessed by the inspector. We have completed a visual inspection of the fixings from ground level but a maintenance inspection should be undertaken to assess the condition, security and wear of the components at intervals in accordance with the manufacturers recommendations.	Action: Inspect in accordance with the manufacturers recommendations
--	---

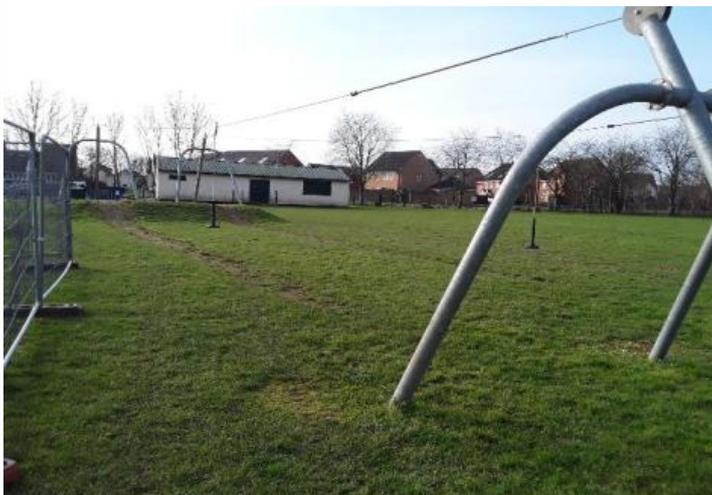
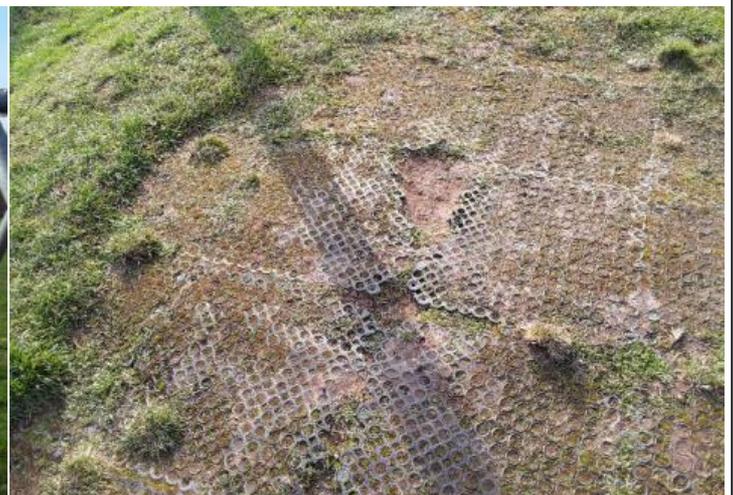
i 8 - Low Risk (Finding 3)

Finding: There is damage to the surface	Action: Repair the damaged areas of surfacing
--	--

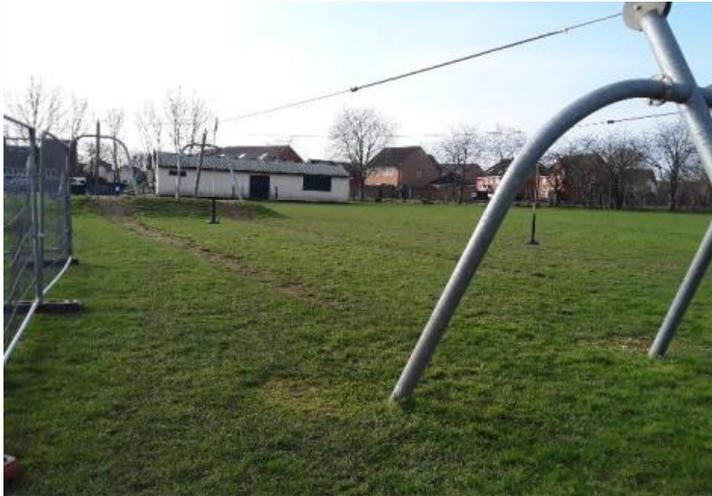
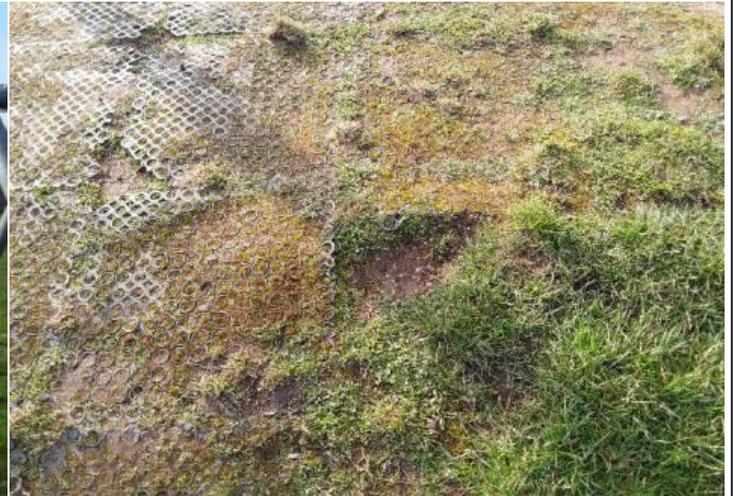
i 8 - Low Risk (Finding 4)

Finding: The edges of the grass mat surface have not been installed in accordance with the API Code of Practice
Action: Tuck in edges of grass mat to remove trip hazards

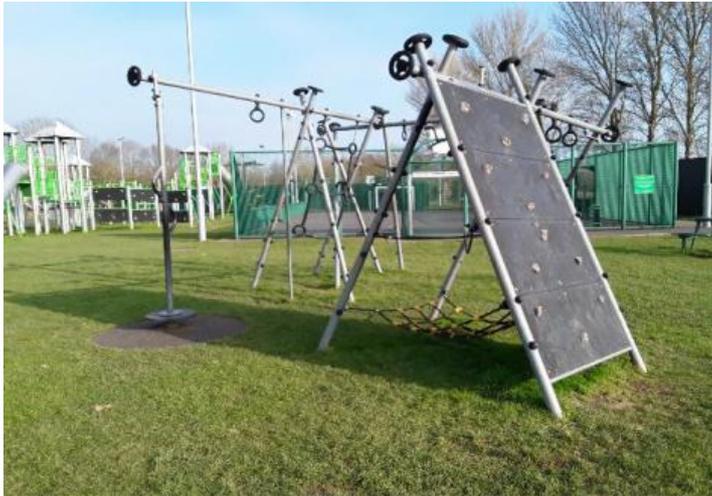
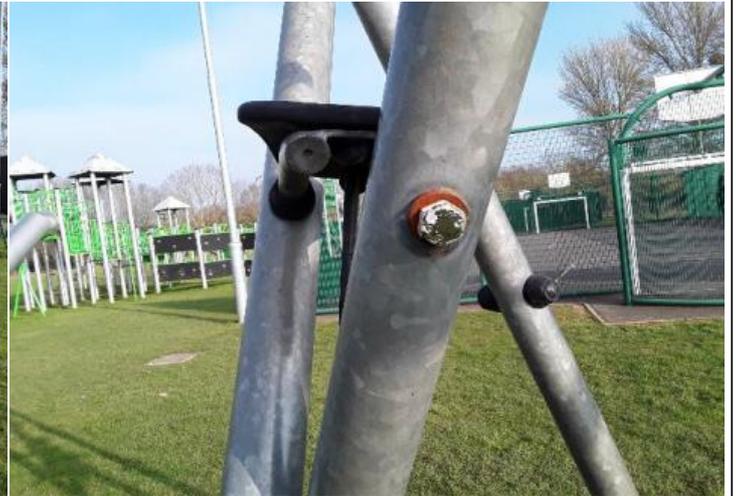
Finding: There is/are bolt cap covers missing or damaged on the item

Action: Replace missing or damaged bolt cap covers

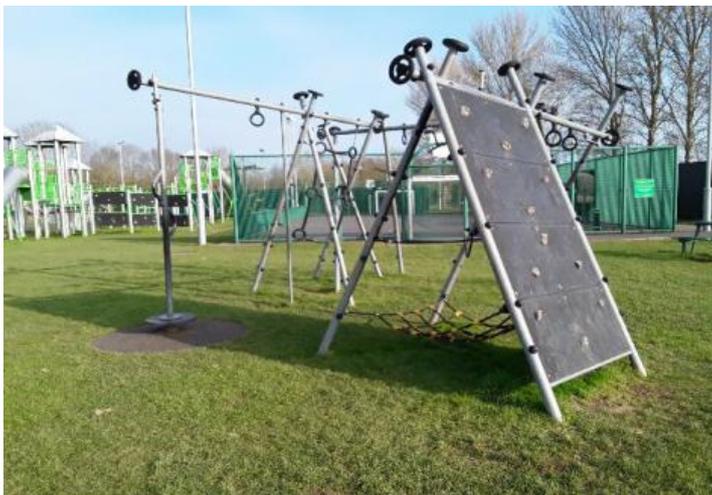
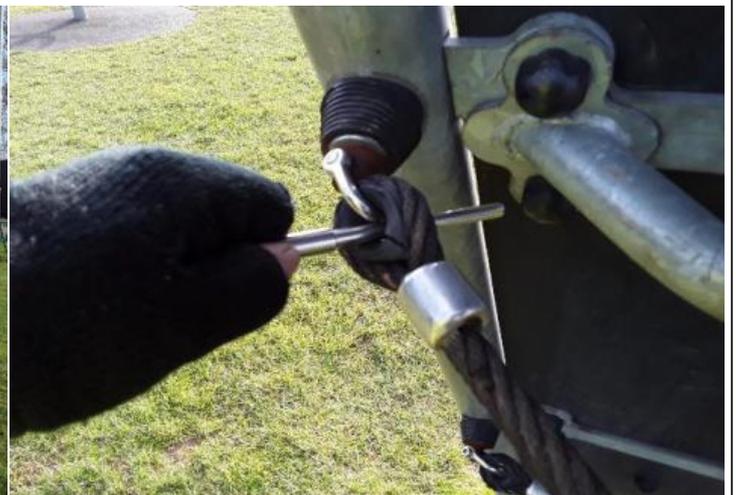
Finding: The connecting links are in excess of 8.6mm and less than 12mm and fail the requirements of BS EN 1176 Part 1; clause 4.2.13, Chains

Action: Monitor use and replace with compliant links at the next maintenance cycle

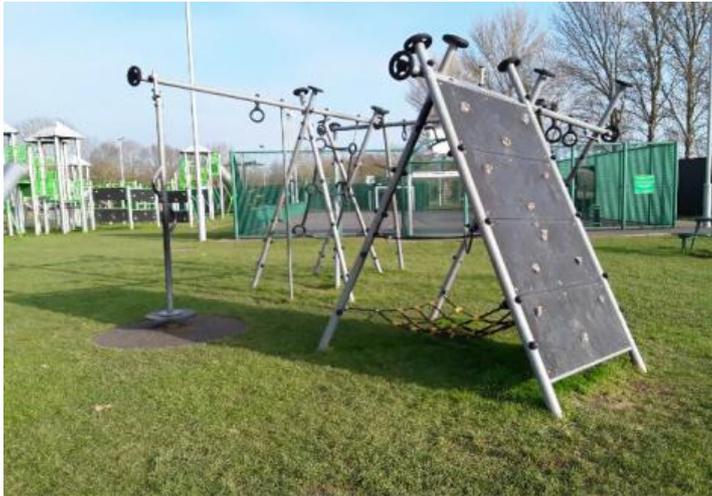
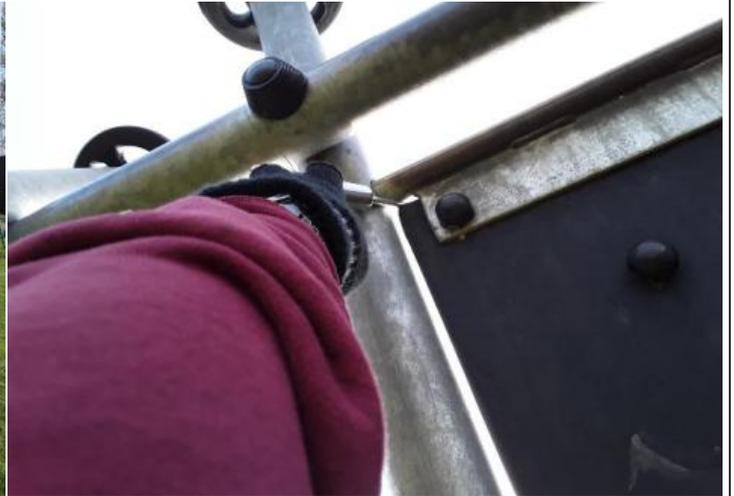
Finding: There is/are finger entrapment/s in the structure and the item fails to meet the requirements of BS EN 1176 Part 1 4.2.7.6 Entrapment of fingers

Action: Monitor - No remedial work recommended

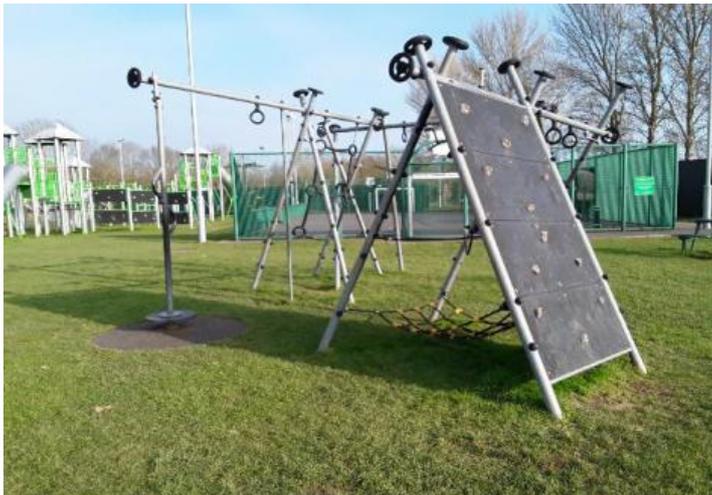
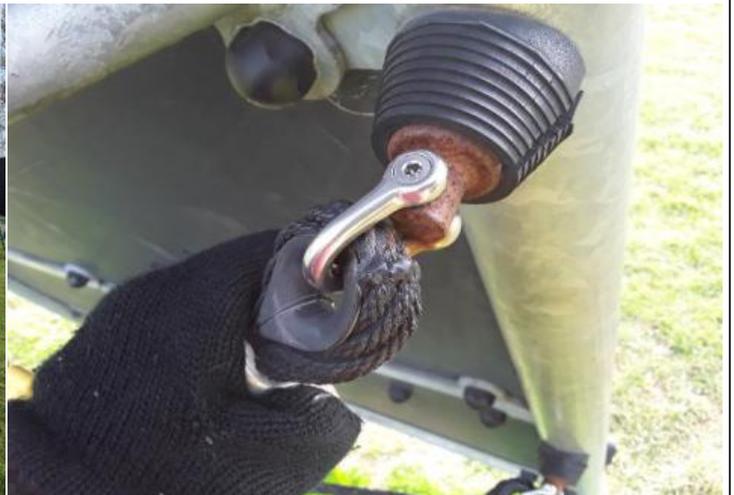
Finding: The shackles have been overtightened or seized transferring wear to the rope connector

Action: Loosen shackles to ensure free movement at the pivot

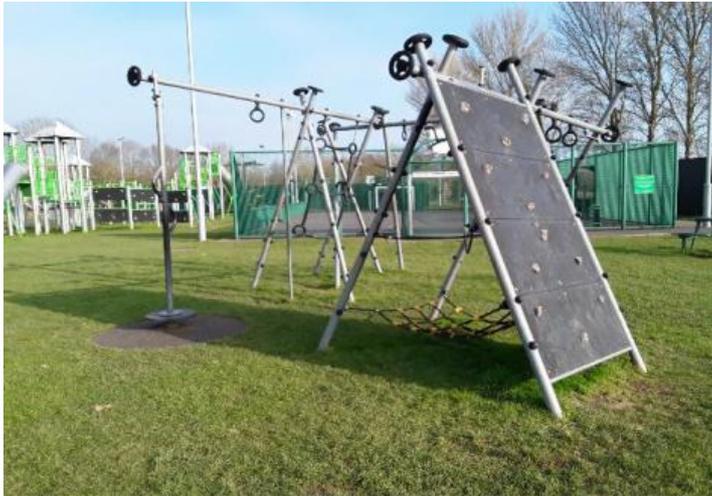
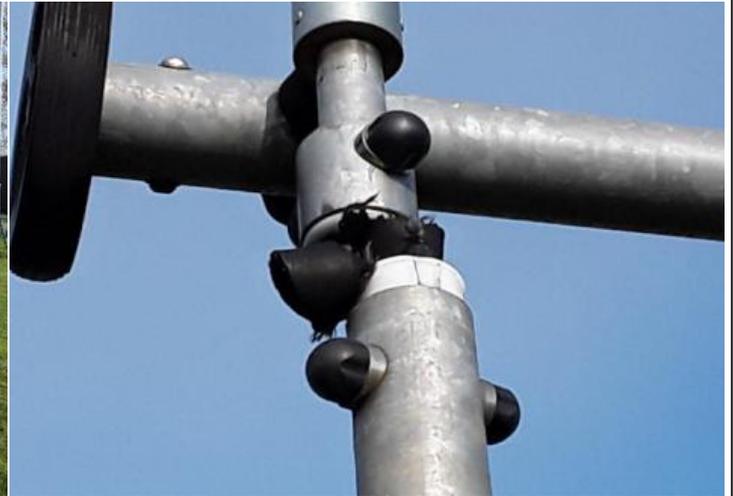
Finding: The universal joint cover over the rotating platform is damaged, split or missing **Action:** Replace the cover

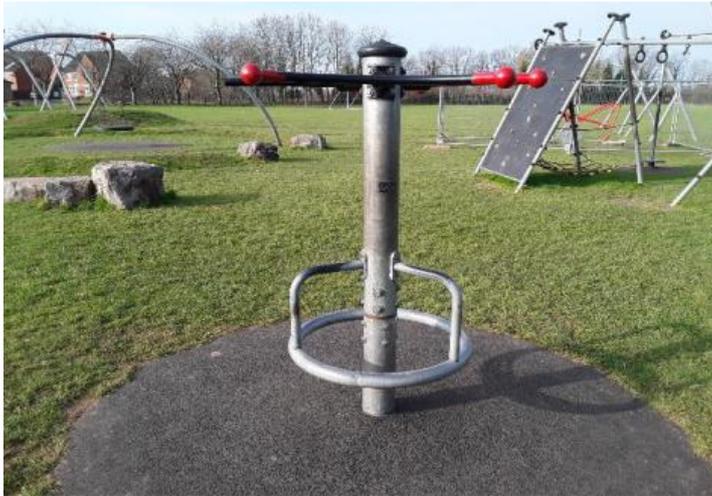
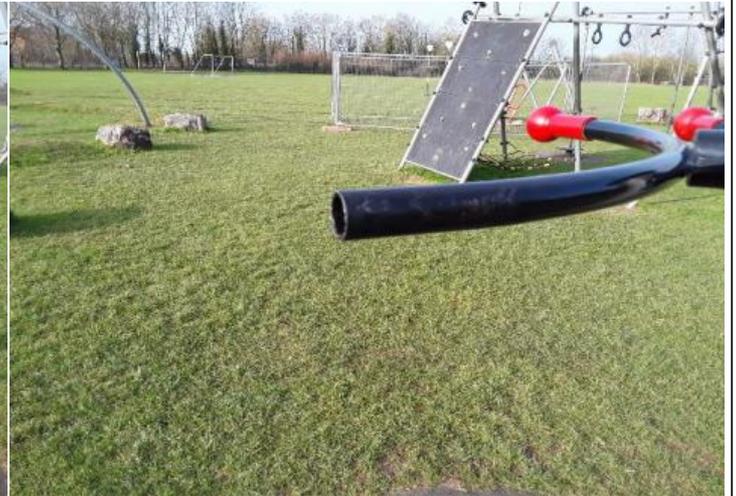
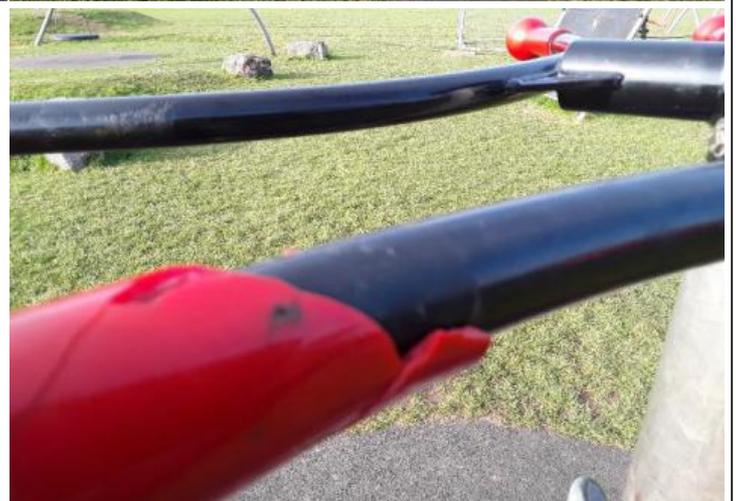
i 8 - Low Risk (Finding 1)

Finding: The handgrips are damaged or missing exposing sharp edges

Action: Replace the handgrips as required

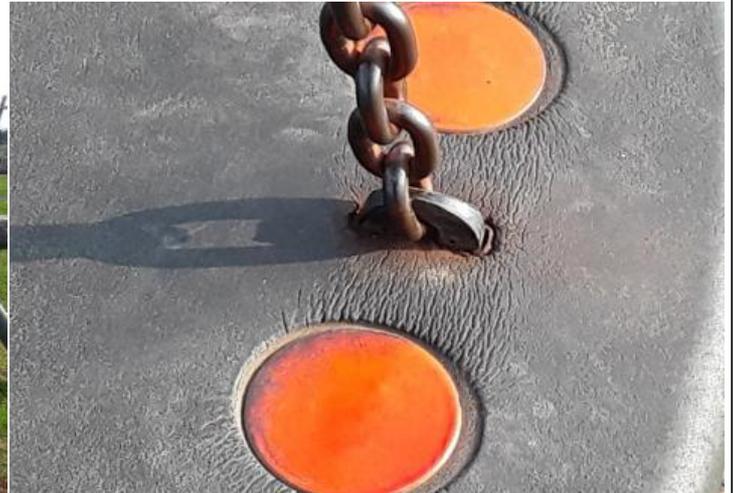
Finding: The connecting lugs are showing signs of wear

Action: Monitor for any further deterioration and repair as required

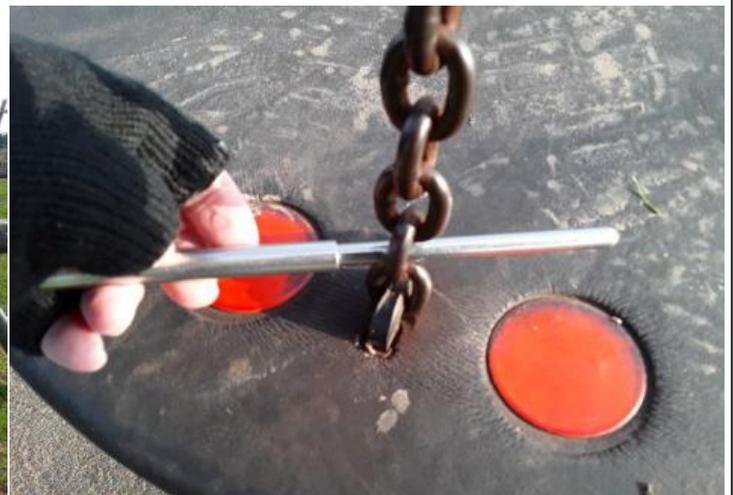
Finding: The chain openings are in excess of the 8.6mm as recommended by BS EN 1176

Action: Monitor - No remedial work recommended

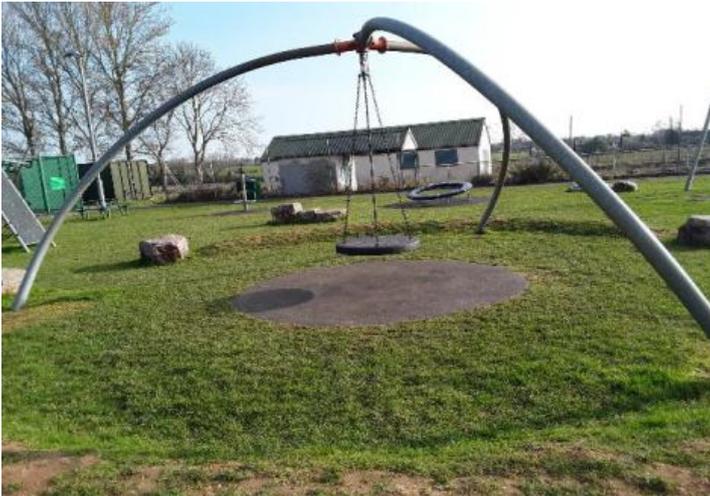
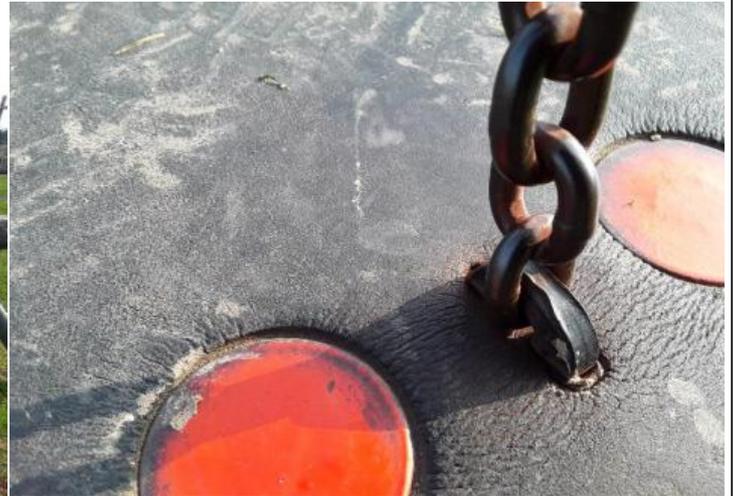
Finding: There is some notable evidence of chain wear

Action: Monitor for any further deterioration and replace when 40% worn

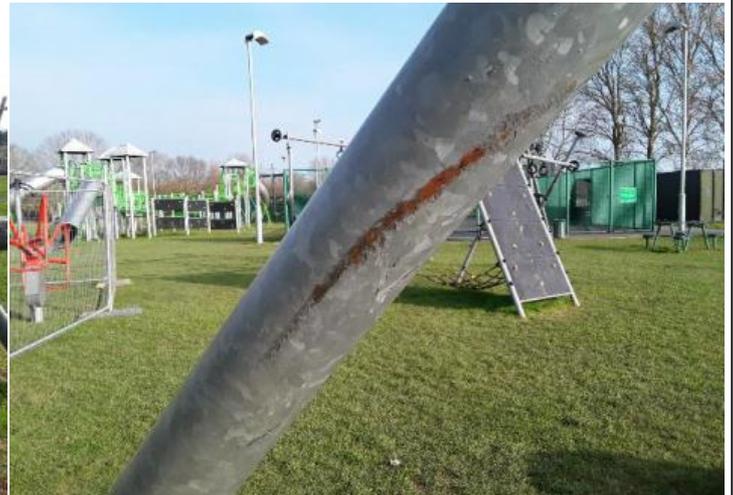
Finding: There is surface corrosion present on the item

Action: Consider treating the item

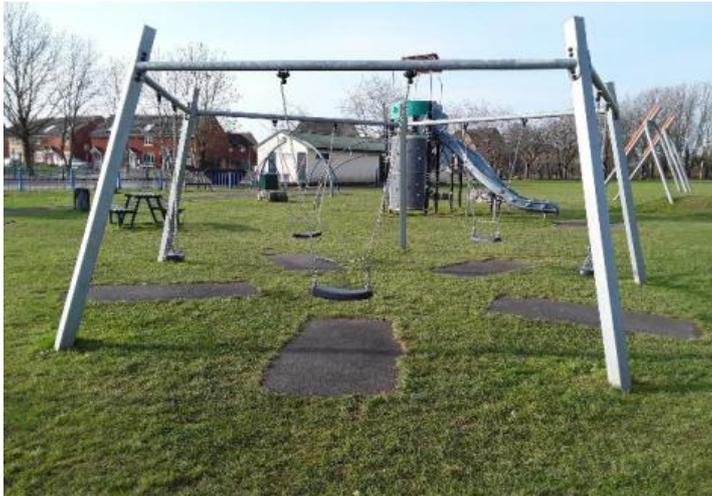
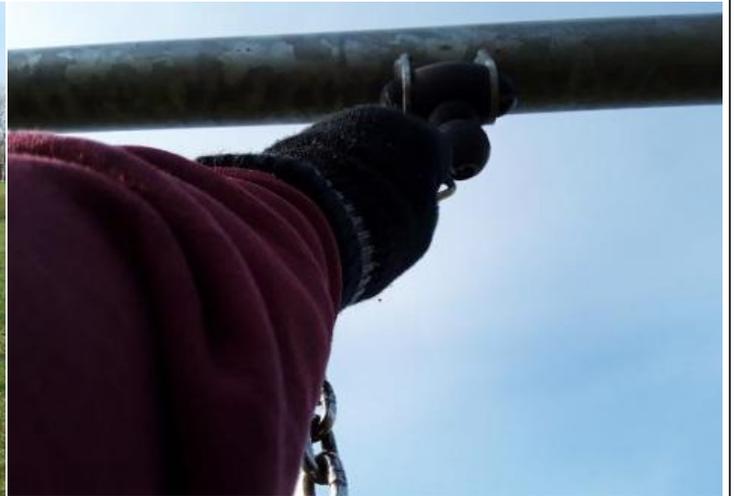
Finding: The chain links are worn in excess of 40% and require renewing

Action: Replace worn chains

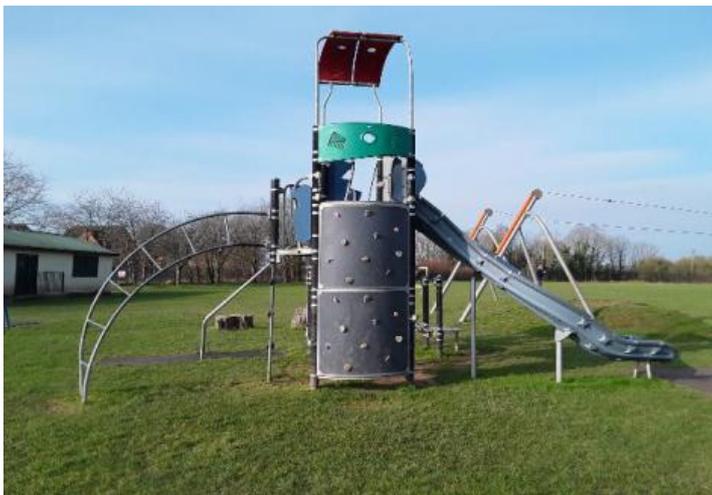
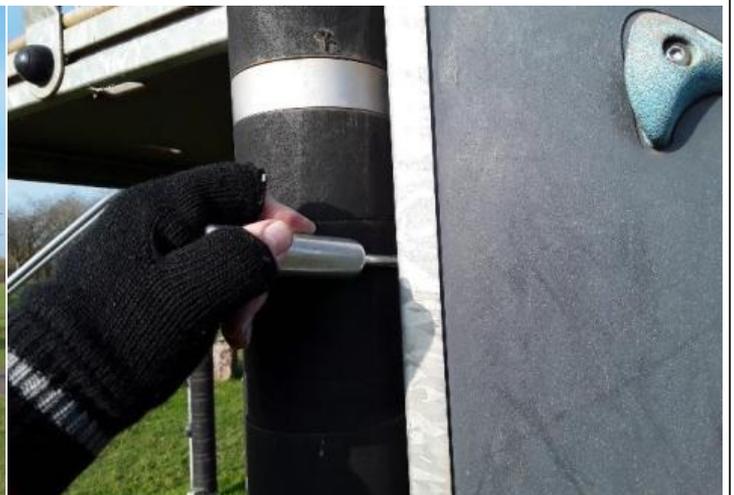
Finding: There is/are finger entrapment/s in the structure adjacent to the climbing wall and the item fails to meet the requirements of BS EN 1176 Part 1 4.2.7.6 Entrapment of fingers

Action: Monitor - No remedial work recommended

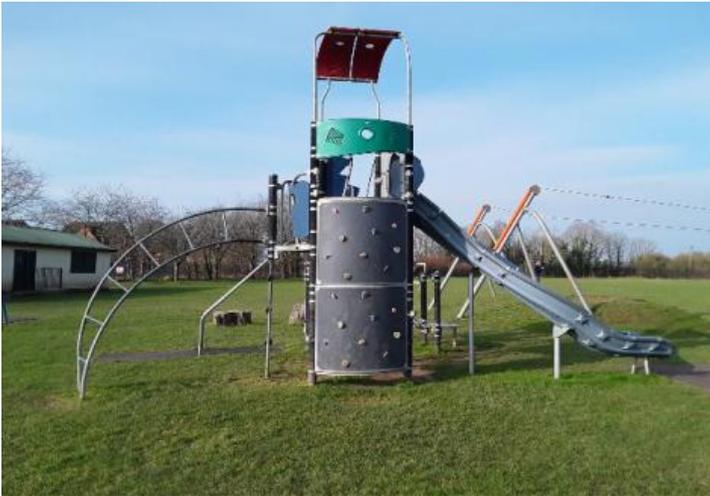
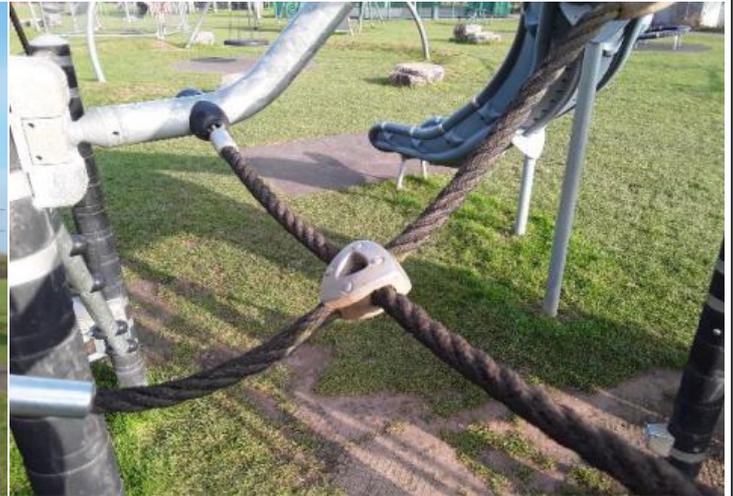
Finding: The ropes/nets are worn/damaged in places

Action: Monitor for any further deterioration and repair or replace as required

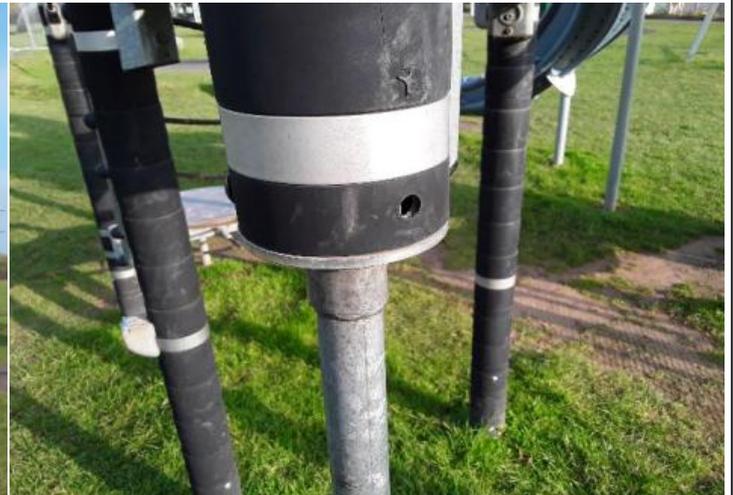
Finding: There is or are fixings missing on the item

Action: Replace all missing fixings

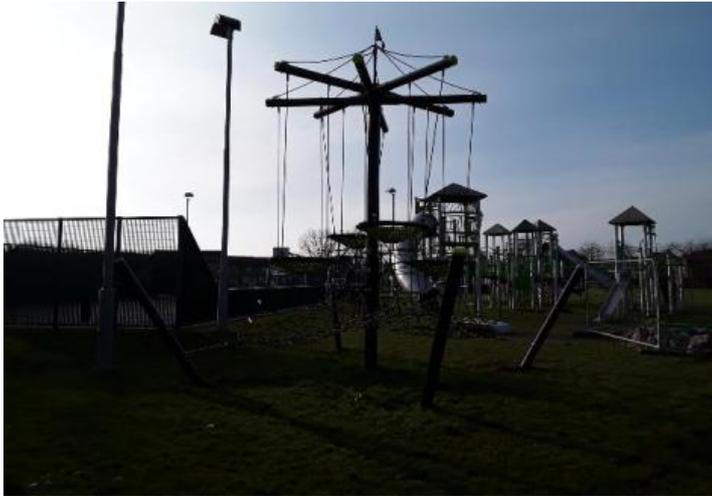
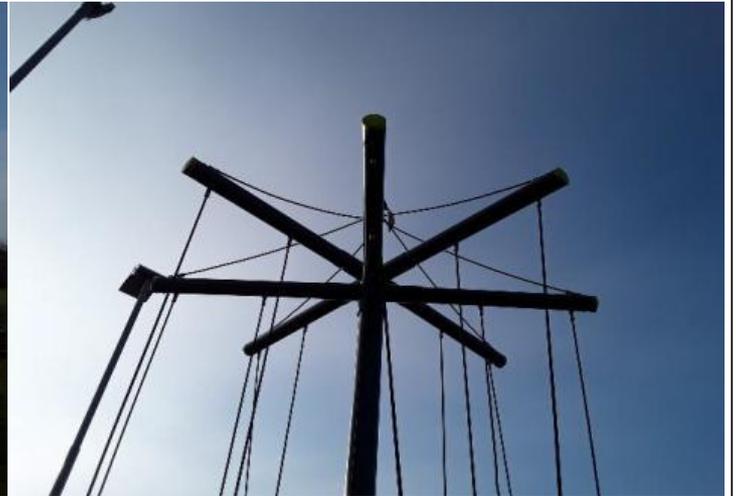
Finding: The fixings or components for this item were in excess of 2.5m above the standing surface and could not be fully accessed by the inspector. We have completed a visual inspection of the fixings from ground level but a maintenance inspection should be undertaken to assess the condition, security and wear of the components at intervals in accordance with the manufacturers recommendations.

Action: Inspect in accordance with the manufacturers recommendations

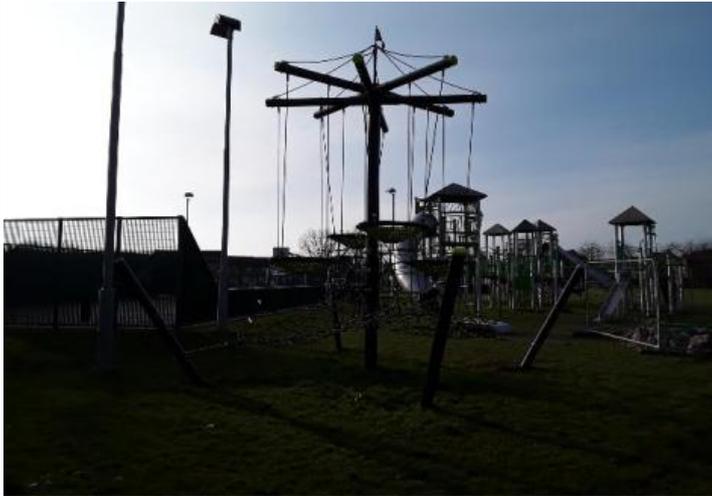
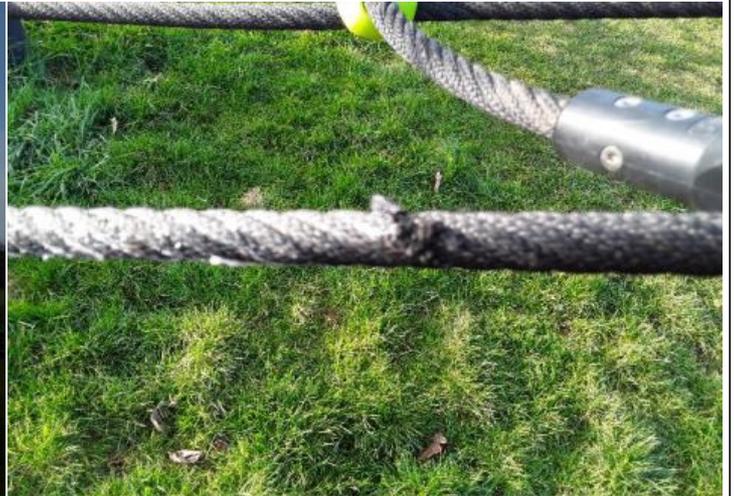
Finding: The ropes/nets are worn/damaged in places

Action: Monitor for any further deterioration and repair or replace as required

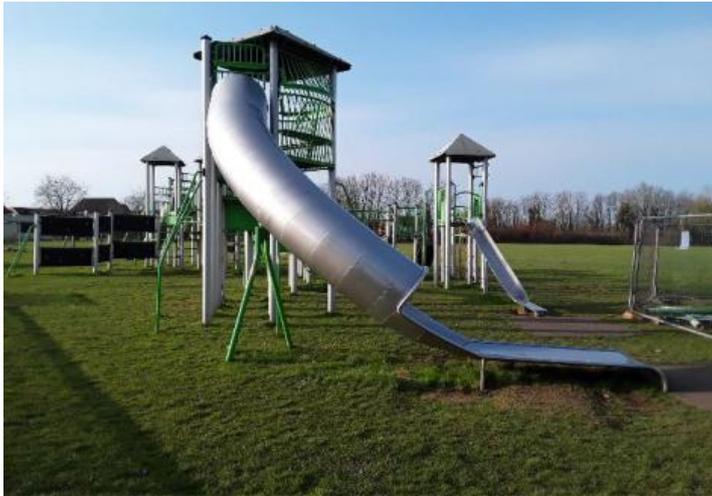
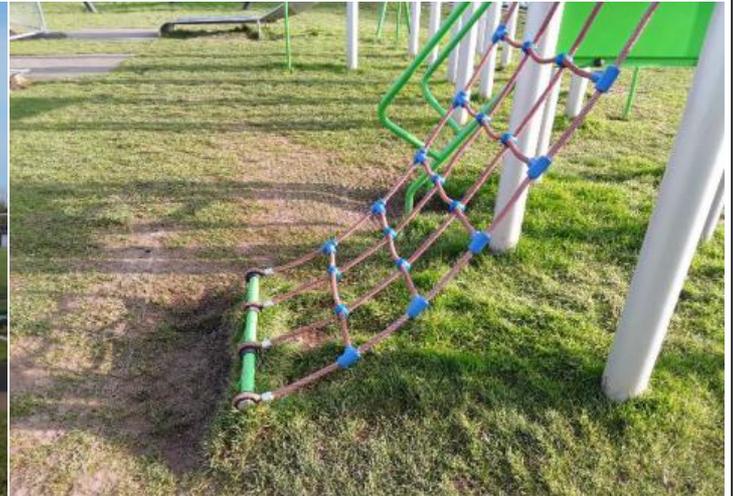
Finding: The rope anchor bar forms a hard object within the falling space of the equipment in contravention of the requirements of BS EN 1176 Part 1
Action: Monitor - No remedial work recommended

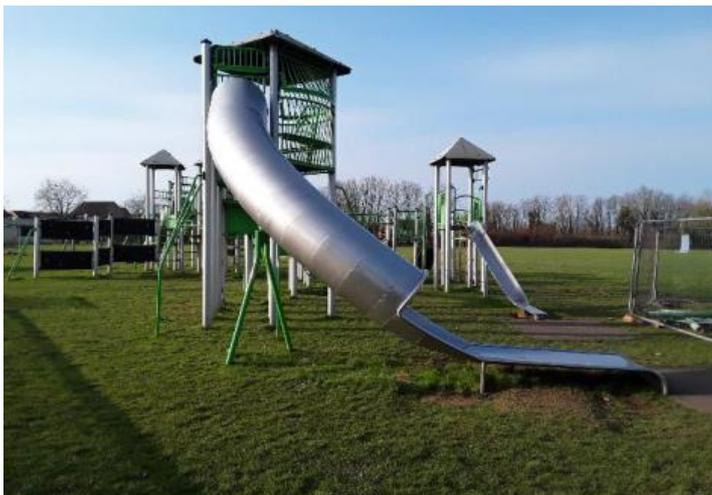
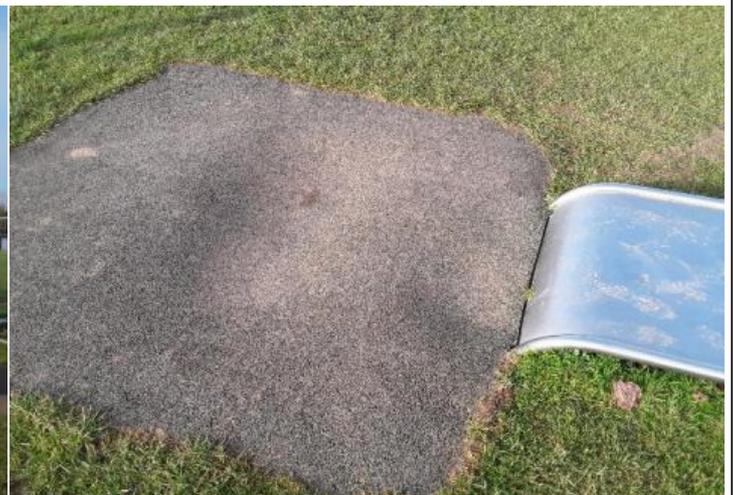
i 6 - Low Risk (Finding 2)

Finding: The surface has subsided in some areas
Action: Monitor for any further deterioration and repair as required

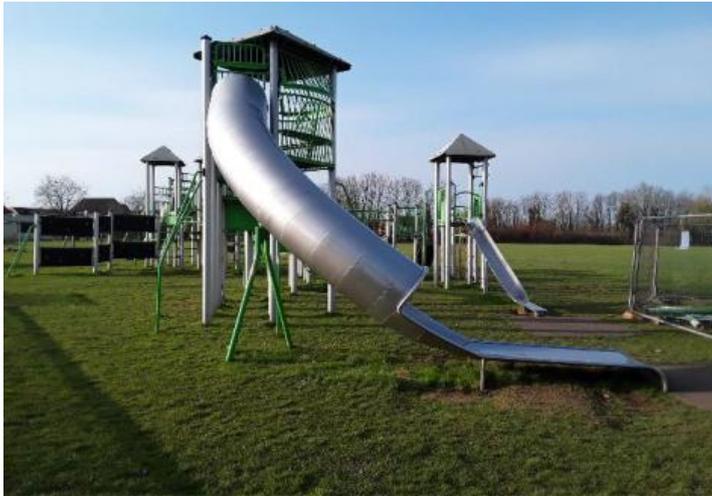
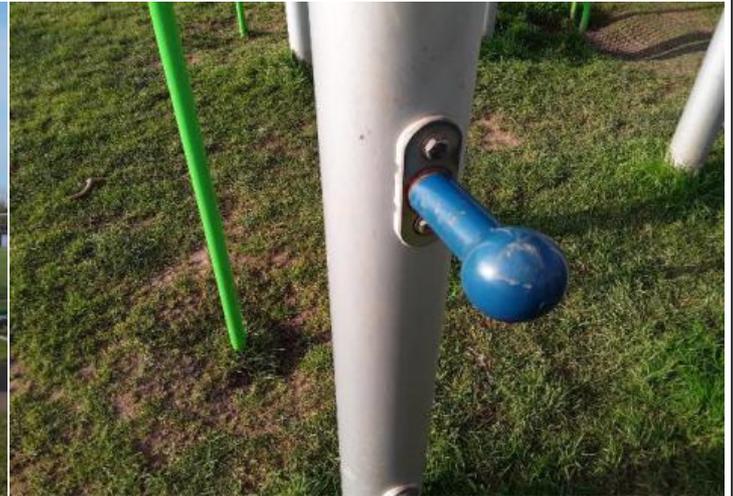
Finding: There is/are bolt cap covers missing or damaged on the item

Action: Replace missing or damaged bolt cap covers
