the **play** inspection company

Annual Inspection

Creech St Michael

Creech St Michael Junior Area

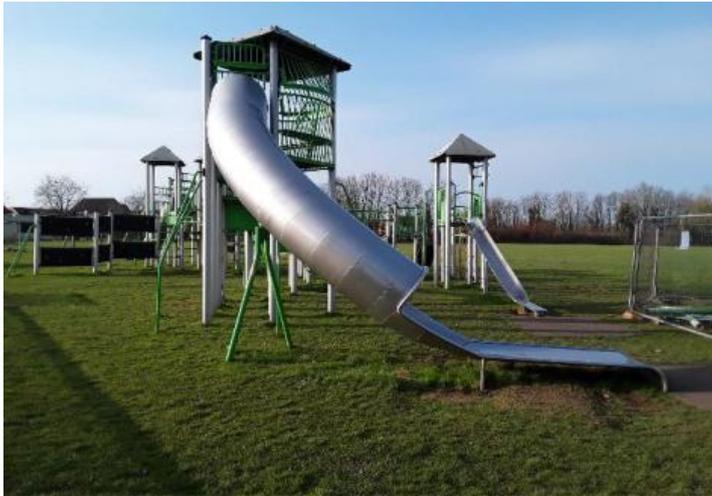
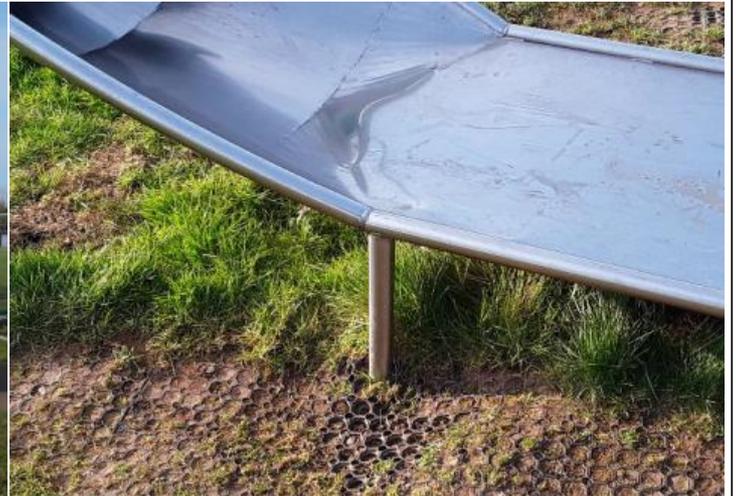
Finding: There are a number of dents in the slide surface

Action: Monitor for any further deterioration and repair as required

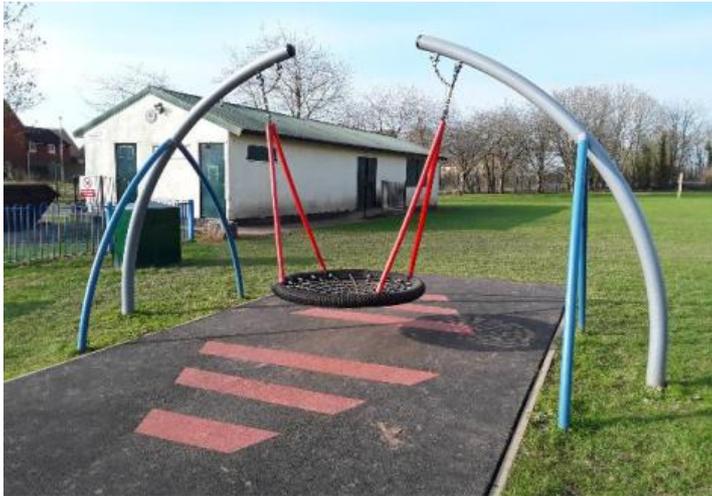
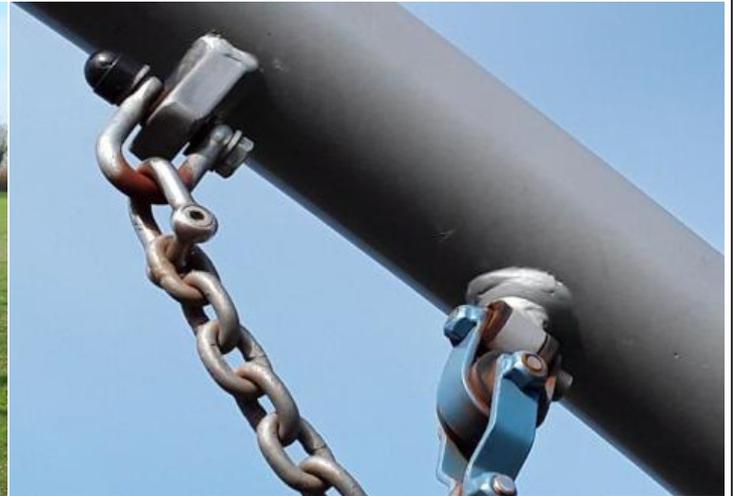
Finding: The bushes are worn or missing

Action: Replace worn or missing bushes

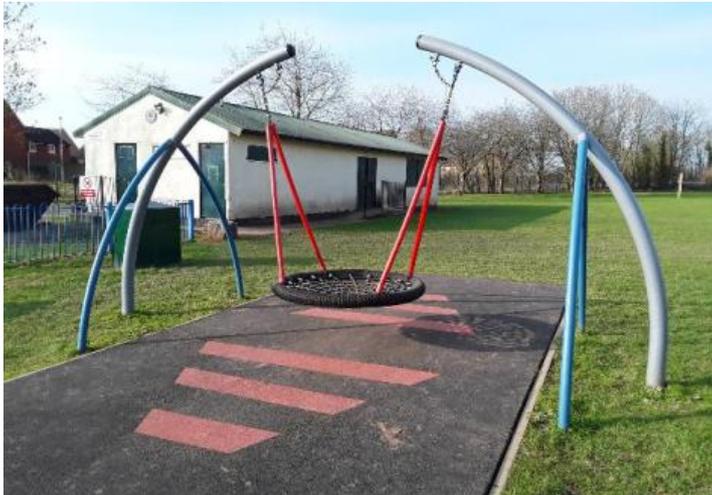
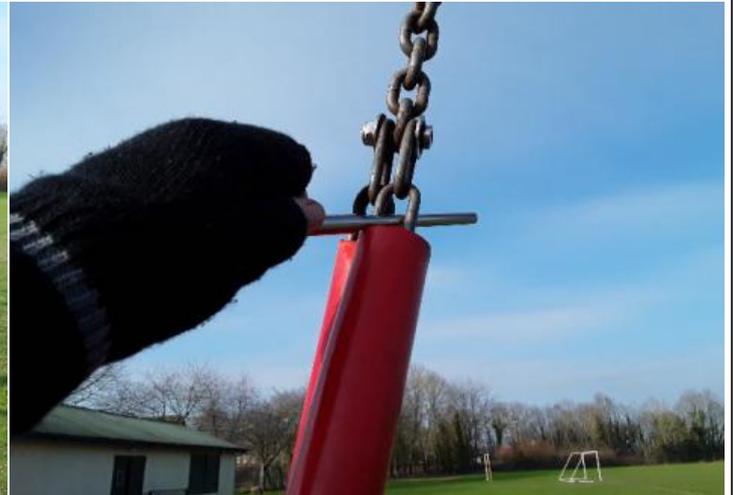
Finding: The chain openings are in excess of the 8.6mm as recommended by BS EN 1176

Action: Monitor - No remedial work recommended

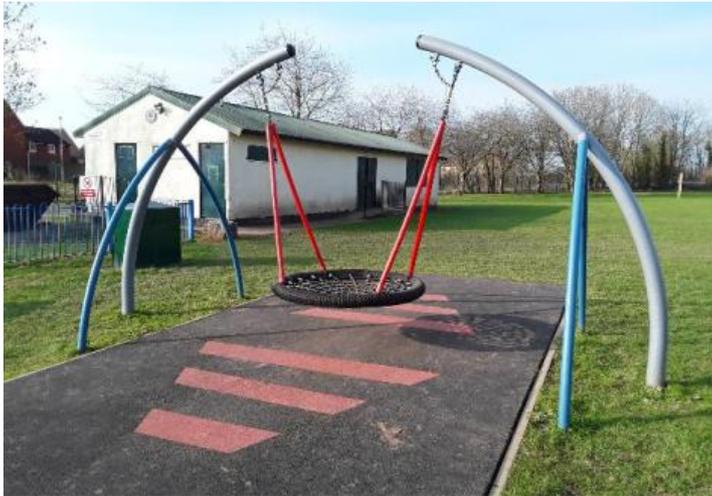
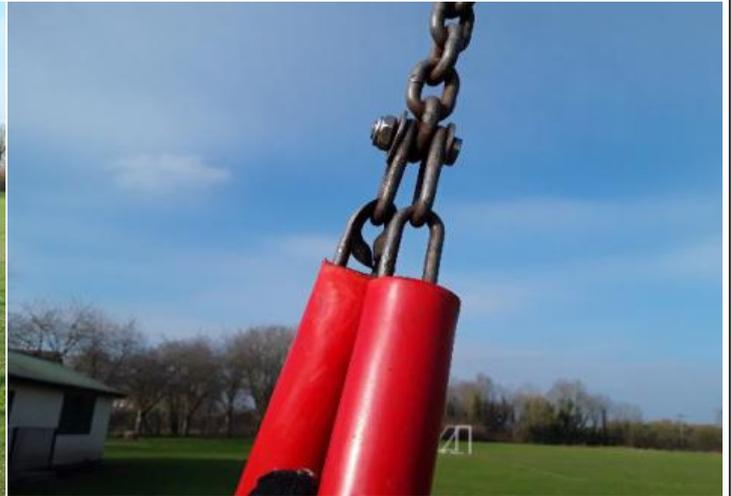
Finding: There is some notable evidence of chain wear

Action: Monitor for any further deterioration and replace when 40% worn

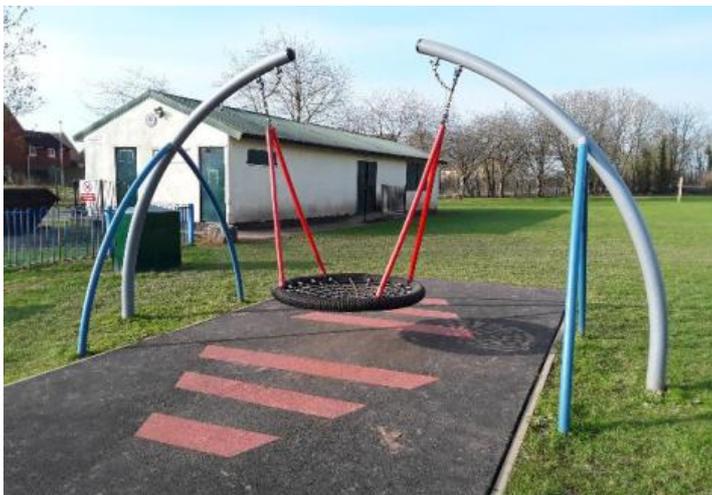
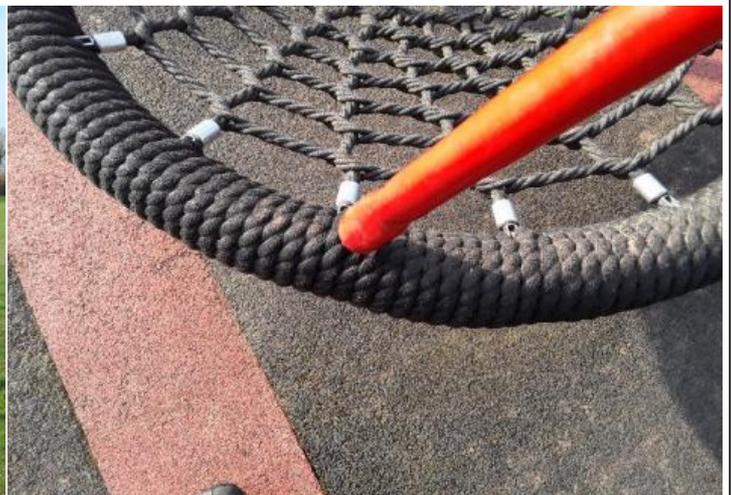
Finding: The seat connection cannot be inspected fully as the chain cover cannot be lifted

Action: Cut the cover to allow access to the shackle and assess the wear

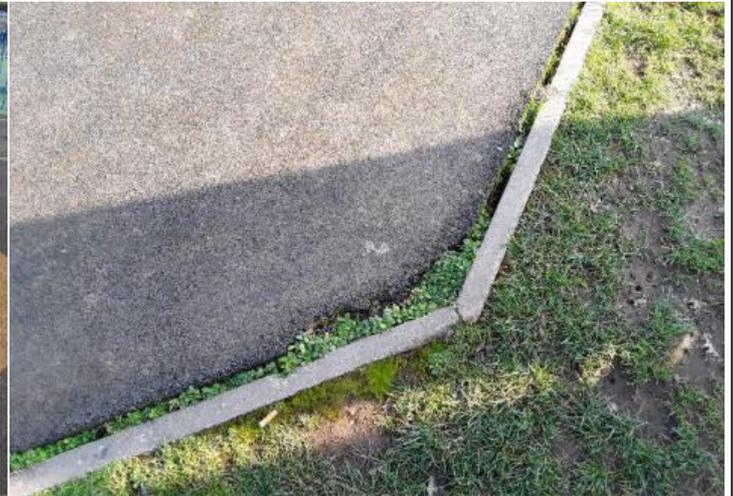
Finding: There is damage to the surface

Action: Repair the damaged areas of surfacing

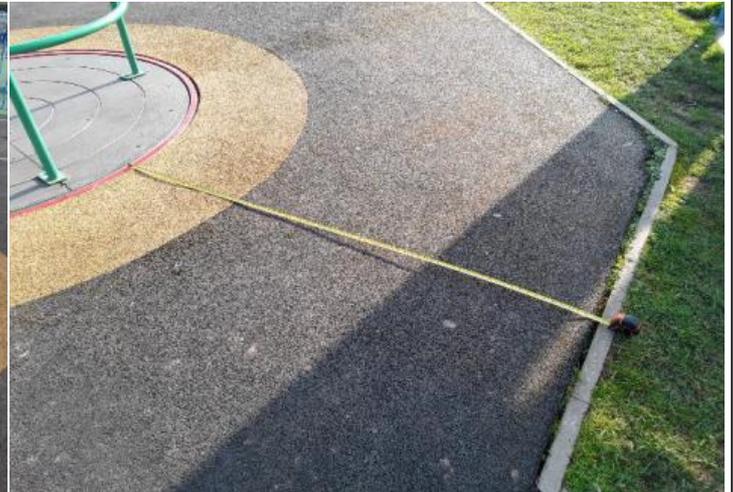
Finding: The surfacing dimensions are short and do not meet with the requirements of the current applicable standard

Action: Monitor - no remedial action recommended

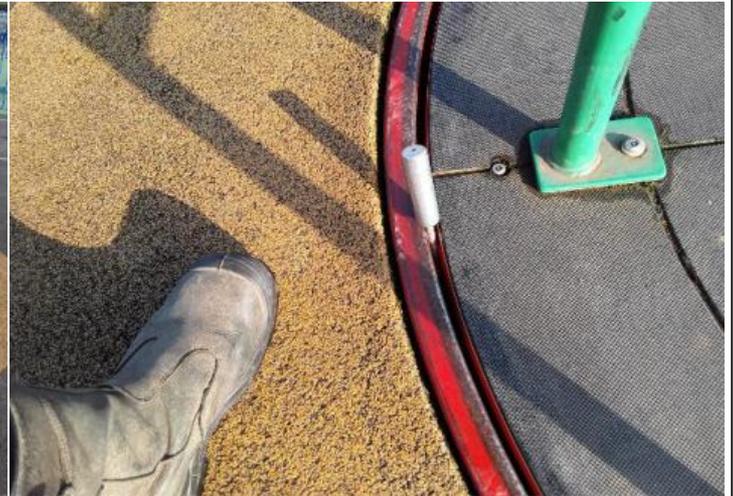
Finding: The opening to the side of the platform is in excess of 8mm and fails the requirements of BS EN 1176 Part 5 **Action:** Adjust / Refer to manufacturer

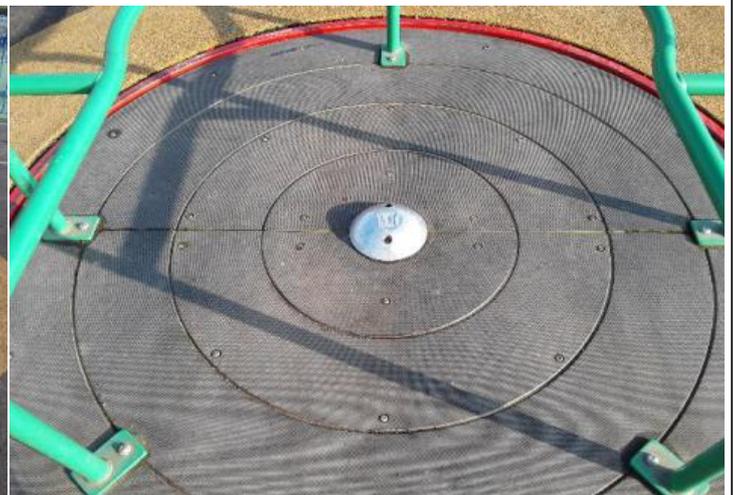
i 10 - Low Risk (Finding 4)

Finding: The bearing is worn / damaged and the item is not operating correctly **Action:** Repair / replace the bearing
