the **play** inspection company

Annual Inspection

Creech St Michael

Creech St Michael Junior Area

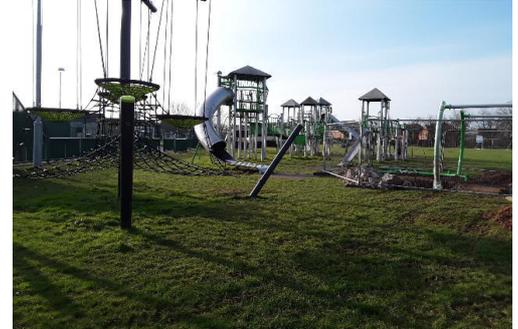
Item: Site General
Manufacturer: Owner/Operator
Surface Type: N/A
Item Quantity: 1
Equipment Compliance: N/A
Surface Area Compliance: N/A

There are trip hazards at the edges of the footpath surface - Reinstate surrounding surface levels to remove the trip points

The surface is lifting at the edges and creating trip points - Repair perimeter of surfacing to remove trip points

There are significant gaps (over 30mm) between the surface and the edging or between the joints in the surface; these are large enough for a small foot to enter - Repair surfacing

The grass mats are silted up and the soil is compacted; this may have an effect on the impact absorbing properties of the surface - Consider HIC testing impact absorbing properties to ensure the correct surface qualities are maintained for the equipment and replace as required

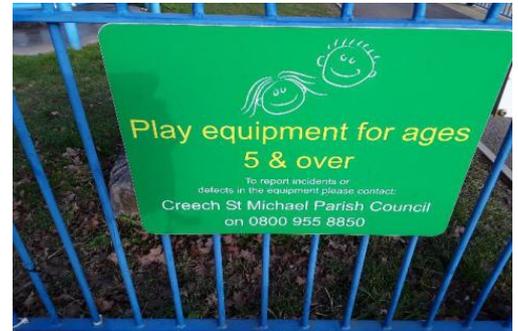
Item: Sign
Manufacturer: Not Identified
Surface Type: N/A
Item Quantity: 1
Equipment Compliance: N/A
Surface Area Compliance: N/A

BS EN 1176 Part 7 recommends that signage shall include the site name / address - Provide additional information

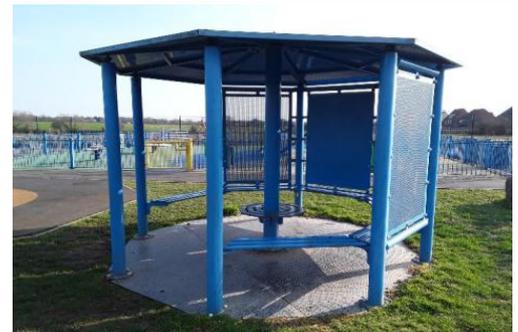
Item: Teenage Shelter
Manufacturer: Owner/Operator
Surface Type: N/A
Item Quantity: 1
Equipment Compliance: N/A
Surface Area Compliance: N/A

There is/are bolt cap covers missing or damaged on the item - Replace missing or damaged bolt cap covers

There are trip hazards present over the shelter base - Reinstate surrounding surfaces to level to remove the trip points

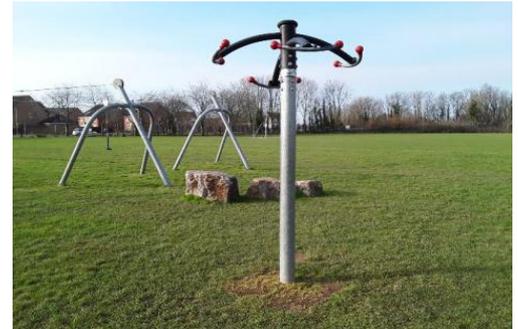
Item: Overhead Rotator
Manufacturer: Sutcliffe Play Limited
Surface Type: Mixed Surface
Item Quantity: 1
Equipment Compliance: Yes
Surface Area Compliance: Yes

There is surface corrosion present on the item - Consider treating the item

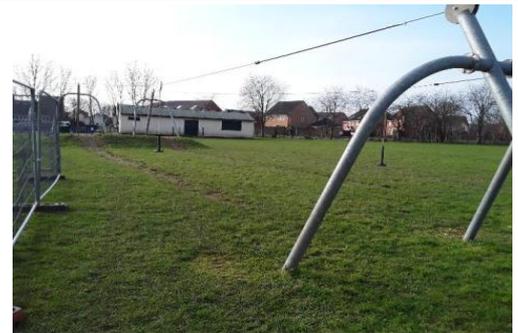
Item: Cable Runway
Manufacturer: Sutcliffe Play Limited
Surface Type: Grass Matrix Tiles
Item Quantity: 2
Equipment Compliance: Yes
Surface Area Compliance: Yes

We have completed a visual inspection of the suspension links, cable and fixing points from ground level, however it is not possible to fully inspect these areas without either hiring equipment to gain access or removing the cable and suspension and inspecting at ground level. We recommend that the main cable and fixing security is thoroughly inspected at least in accordance with the manufacturers recommendations to check for wear, damage, security or internal rusting; this will help to ensure the continued safe use of the equipment - Inspect in accordance with the manufacturers recommendations

The fixings or components for this item were in excess of 2.5m above the standing surface and could not be fully accessed by the inspector. We have completed a visual inspection of the fixings from ground level but a maintenance inspection should be undertaken to assess the condition, security and wear of the components at intervals in accordance with the manufacturers recommendations. - Inspect in accordance with the manufacturers recommendations

There is damage to the surface - Repair the damaged areas of surfacing

The edges of the grass mat surface have not been installed in accordance with the API Code of Practice - Tuck in edges of grass mat to remove trip hazards

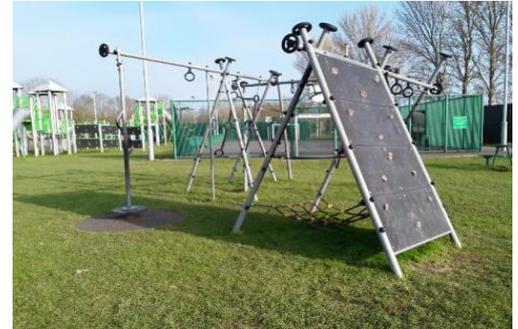
Item: Climbing Frame
Manufacturer: Sutcliffe Play Limited
Surface Type: Grass Matrix Tiles
Item Quantity: 1
Equipment Compliance: No
Surface Area Compliance: Yes

There is/are bolt cap covers missing or damaged on the item - Replace missing or damaged bolt cap covers

The connecting links are in excess of 8.6mm and less than 12mm and fail the requirements of BS EN 1176 Part 1; clause 4.2.13, Chains - Monitor use and replace with compliant links at the next maintenance cycle

There is/are finger entrapment/s in the structure and the item fails to meet the requirements of BS EN 1176 Part 1 4.2.7.6 Entrapment of fingers - Monitor - No remedial work recommended

The shackles have been overtightened or seized transferring wear to the rope connector - Loosen shackles to ensure free movement at the pivot

The universal joint cover over the rotating platform is damaged, split or missing - Replace the cover

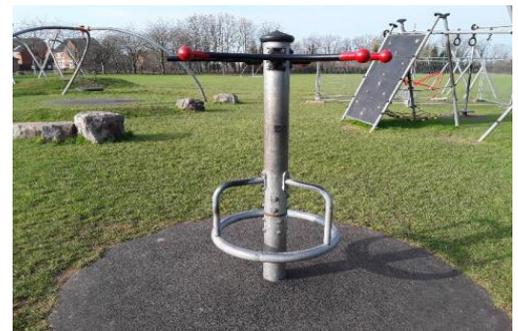
Item: Low Rotator
Manufacturer: Sutcliffe Play Limited
Surface Type: Mixed Surface
Item Quantity: 1
Equipment Compliance: Yes
Surface Area Compliance: Yes

The handgrips are damaged or missing exposing sharp edges - Replace the handgrips as required

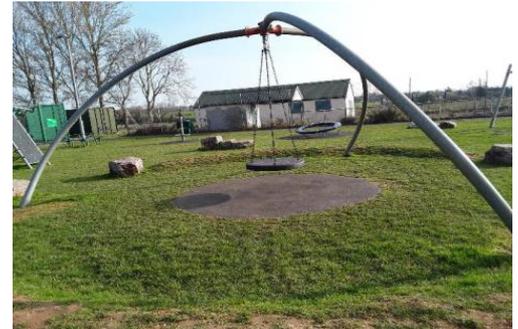
Item: Single Point Swing - Type 3
Manufacturer: Sutcliffe Play Limited
Surface Type: Mixed Surface
Item Quantity: 1
Equipment Compliance: No
Surface Area Compliance: Yes

The connecting lugs are showing signs of wear - Monitor for any further deterioration and repair as required

The chain openings are in excess of the 8.6mm as recommended by BS EN 1176 - Monitor - No remedial work recommended

There is some notable evidence of chain wear - Monitor for any further deterioration and replace when 40% worn

There is surface corrosion present on the item - Consider treating the item

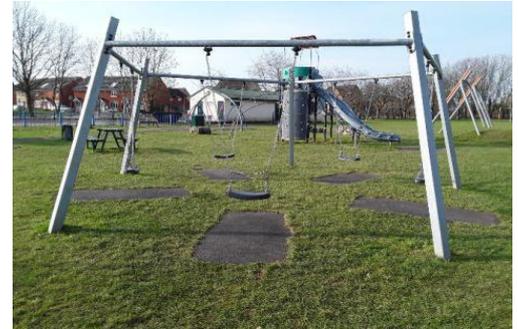
Item: Contact Swing - Type 4
Manufacturer: Kompan Ltd
Surface Type: Mixed Surface
Item Quantity: 1
Equipment Compliance: Yes
Surface Area Compliance: Yes

The chain links are worn in excess of 40% and require renewing - Replace worn chains

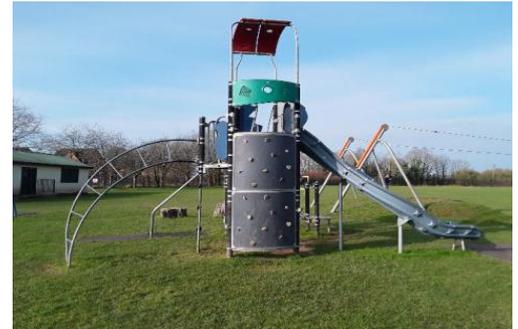
Item: Multi Play (Junior)
Manufacturer: Kompan Ltd
Surface Type: Mixed Surface
Item Quantity: 1
Equipment Compliance: No
Surface Area Compliance: Yes

There is/are finger entrapment/s in the structure adjacent to the climbing wall and the item fails to meet the requirements of BS EN 1176 Part 1 4.2.7.6 Entrapment of fingers - Monitor - No remedial work recommended

The ropes/nets are worn/damaged in places - Monitor for any further deterioration and repair or replace as required

There is or are fixings missing on the item - Replace all missing fixings

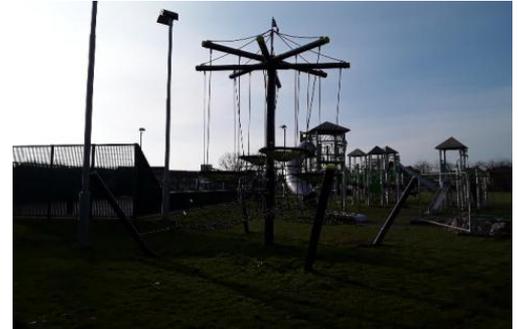
Item: Net Climber
Manufacturer: Huck Nets (UK) Ltd
Surface Type: Grass Matrix Tiles
Item Quantity: 1
Equipment Compliance: Yes
Surface Area Compliance: Yes

The fixings or components for this item were in excess of 2.5m above the standing surface and could not be fully accessed by the inspector. We have completed a visual inspection of the fixings from ground level but a maintenance inspection should be undertaken to assess the condition, security and wear of the components at intervals in accordance with the manufacturers recommendations. - Inspect in accordance with the manufacturers recommendations

The ropes/nets are worn/damaged in places - Monitor for any further deterioration and repair or replace as required

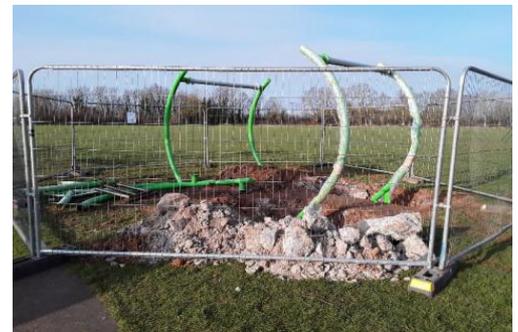
Item: Rope Swing
Manufacturer: Sutcliffe Play Limited
Surface Type: Grass Matrix Tiles
Item Quantity: 1
Equipment Compliance: Yes
Surface Area Compliance: Yes

The item has been fenced off while being reinstated - Ensure that the item is inspected prior to allowing public access

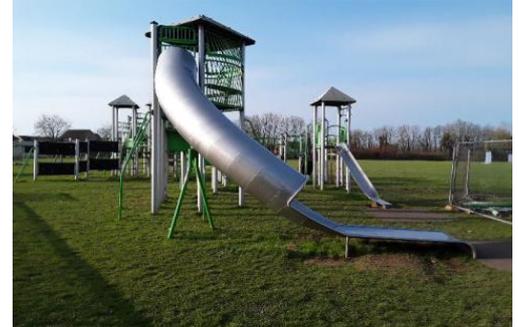
Item: Multi Play (Junior)
Manufacturer: Sutcliffe Play Limited
Surface Type: Grass Matrix Tiles
Item Quantity: 1
Equipment Compliance: No
Surface Area Compliance: Yes

The rope anchor bar forms a hard object within the falling space of the equipment in contravention of the requirements of BS EN 1176 Part 1 - Monitor - No remedial work recommended

The surface has subsided in some areas - Monitor for any further deterioration and repair as required

There is/are bolt cap covers missing or damaged on the item - Replace missing or damaged bolt cap covers

There are a number of dents in the slide surface - Monitor for any further deterioration and repair as required

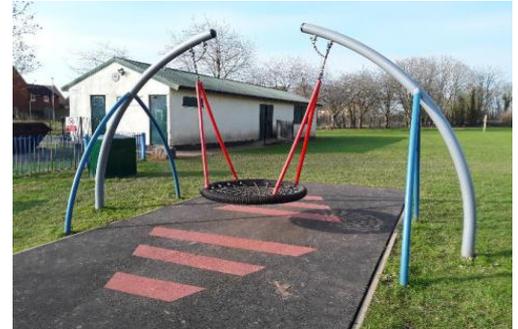
Item: Basket Swing - Type 1
Manufacturer: Not Identified
Surface Type: Wet Pour
Surface Nominal Depth: 65mm
Item Quantity: 1
Equipment Compliance: No
Surface Area Compliance: Yes
Total Findings: 5

The seat clearance from finished surface level to the underside of the seat is too low and does not meet the requirements of BS EN 1176 Part 2 (400mm minimum clearance required from rigid part of seat in most onerous position) - Adjust seat clearance

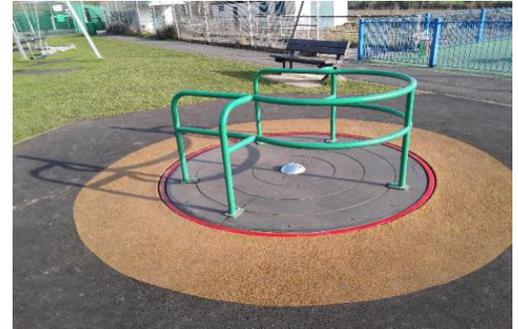
Item: Roundabout
Manufacturer: Not Identified
Surface Type: Wet Pour
Item Quantity: 1
Equipment Compliance: No
Surface Area Compliance: Yes

There is damage to the surface - Repair the damaged areas of surfacing

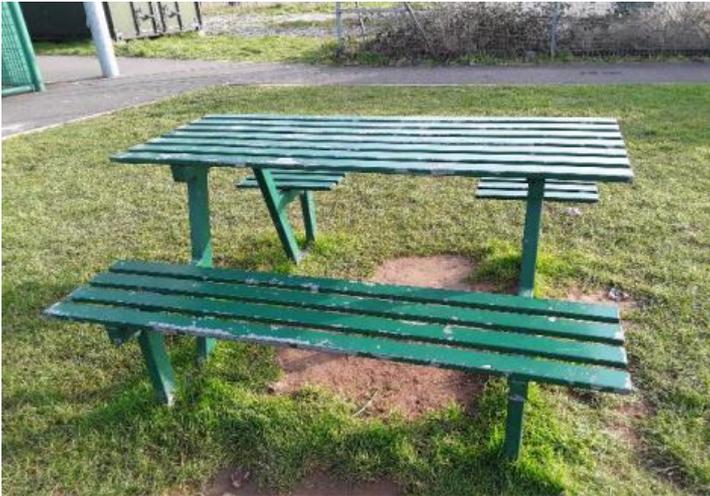
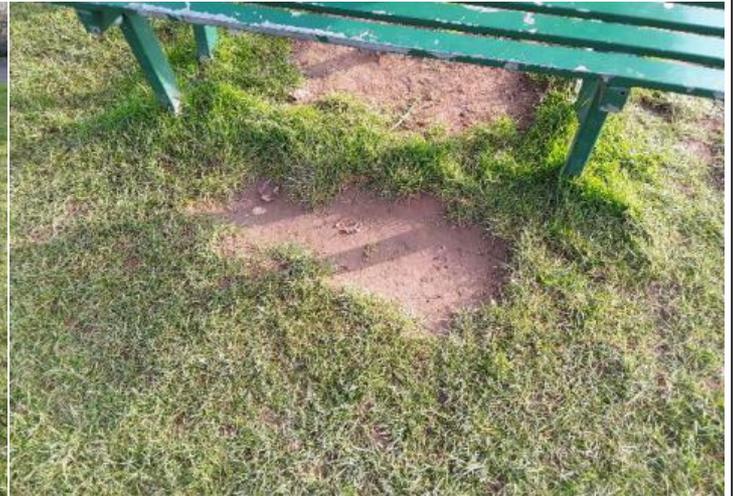
Item: Ancillary Items - Picnic Table
Manufacturer: Owner/Operator

Finding: The area around the item has eroded and may become slippery

Action: Reinststate eroded area

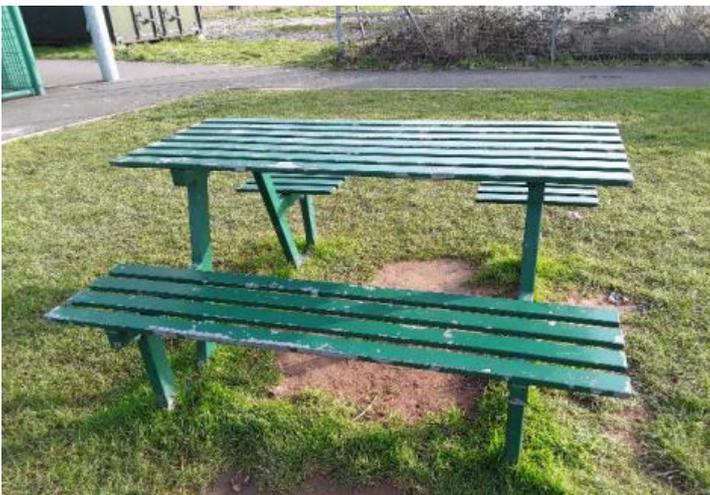
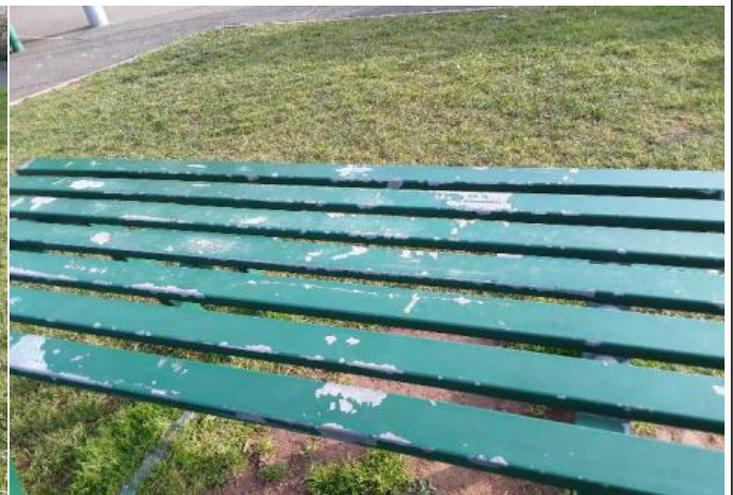
Item: Ancillary Items - Picnic Table
Manufacturer: Owner/Operator

Finding: The paint is flaking off the metalwork

Action: Rub down and re-paint

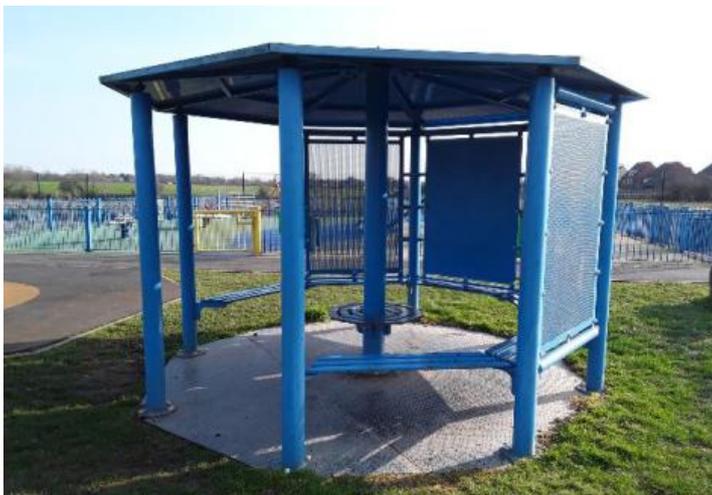
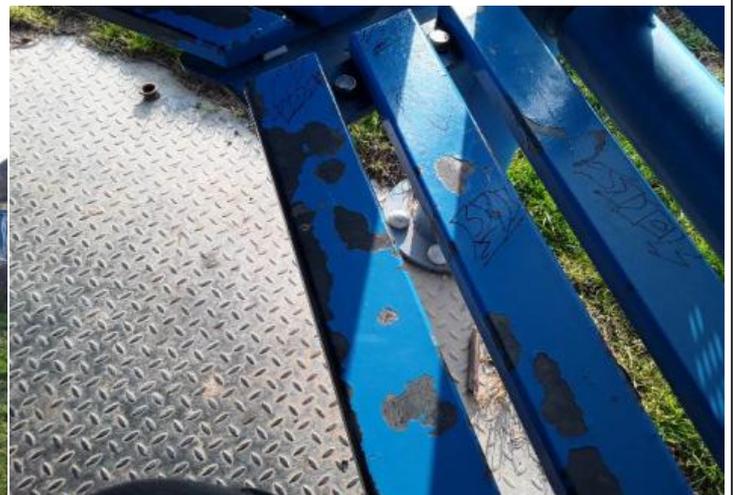
Item: Ancillary Items - Teenage Shelter
Manufacturer: Owner/Operator

Finding: There is some graffiti present

Action: Remove the graffiti

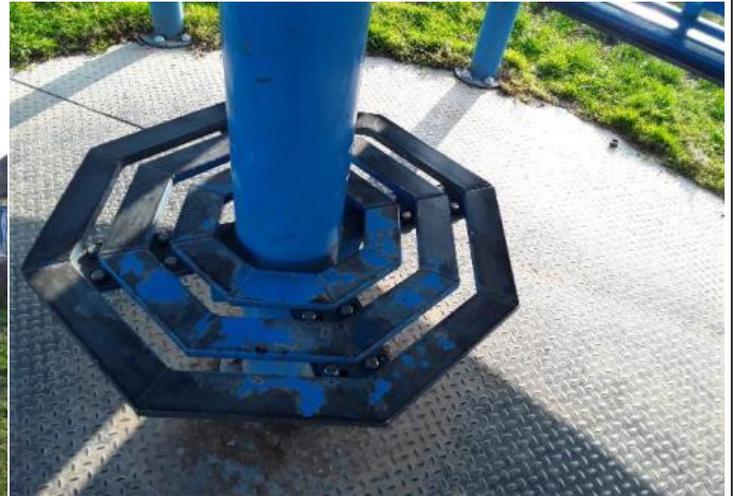
Item: Ancillary Items - Teenage Shelter
Manufacturer: Owner/Operator

Finding: The paint is flaking off the metalwork

Action: Rub down and re-paint

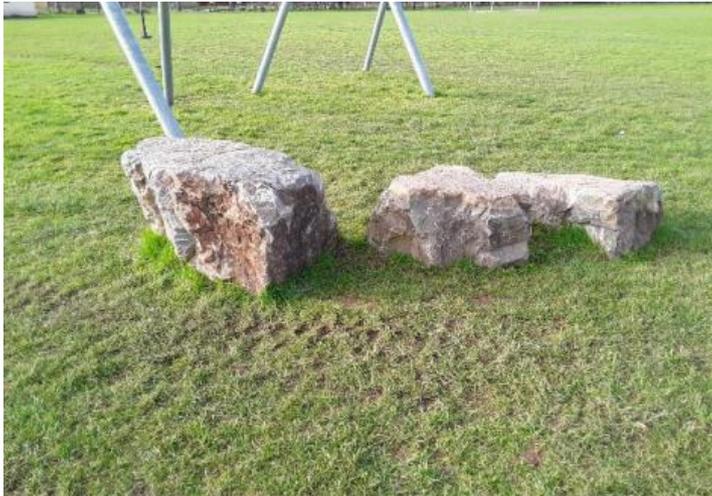
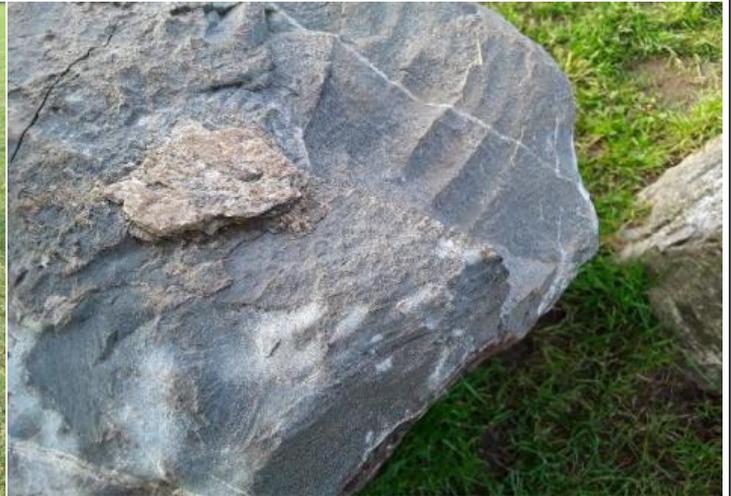
Item: Other - Boulders
Manufacturer: Owner/Operator

Finding: The rocks and/or boulders have sharp edges that are exposed to the user
Action: Remove all sharp edges

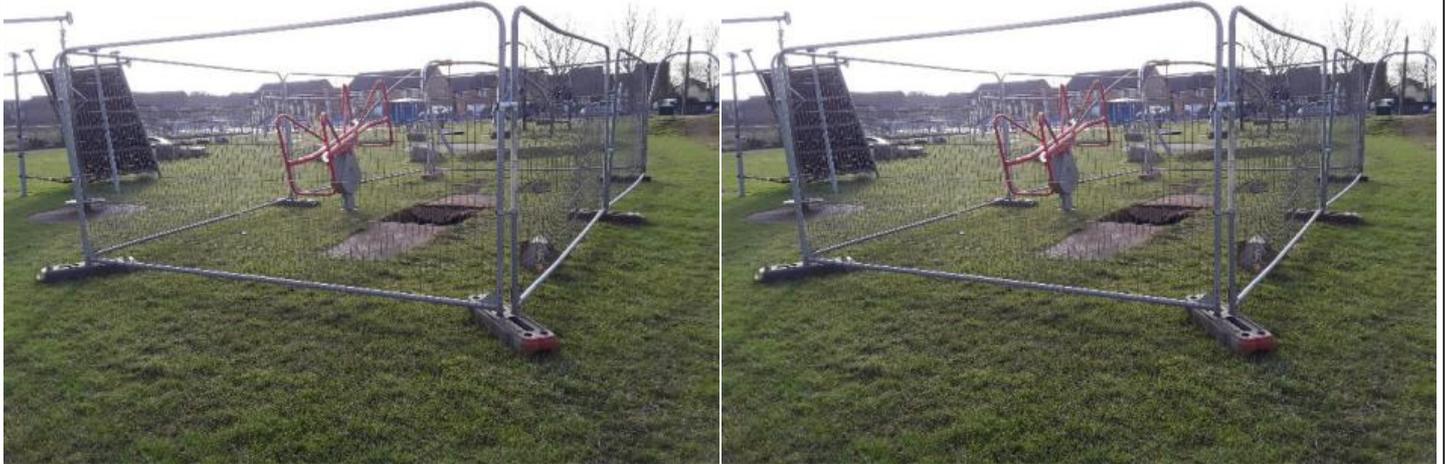
Item: Rocking Equipment - See Saw
Manufacturer: Sutcliffe Play Limited

Finding: The item has been fenced off while it is being reinstalled

Action: Ensure that the item is inspected prior to allowing public access

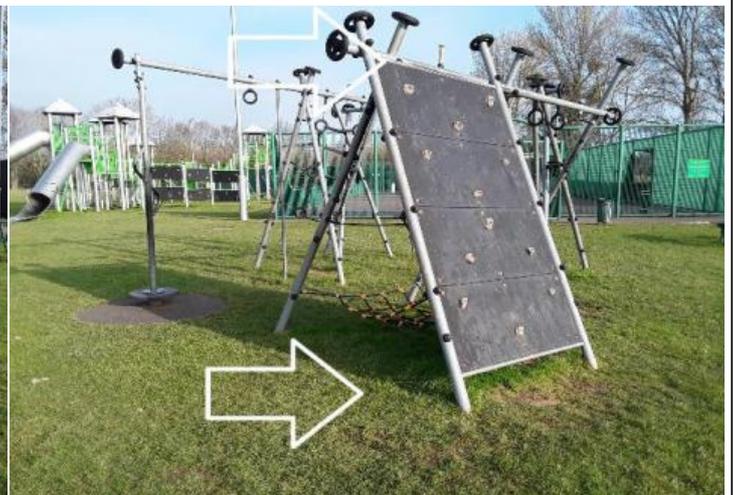
Item: Activity Equipment - Climbing Frame
Manufacturer: Sutcliffe Play Limited

Finding: This item of equipment has a fall height in excess of 2.5m and grass mats have been installed as an impact absorbing surface; these mats rely heavily on the underlying surface to achieve their critical fall height properties.
Action: Ensure surfacing certification is sought and consider HIC testing to ensure the surfacing is performing adequately

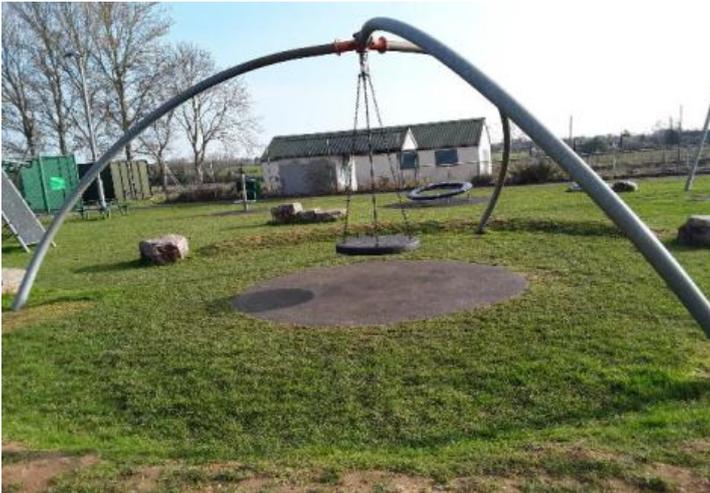
Item: Swings - Single Point Swing - Type 3
Manufacturer: Sutcliffe Play Limited

Risk Level: L - Low Risk
Surface: Mixed Surface

Finding: The connecting lugs are showing signs of wear

Action: Monitor for any further deterioration and repair as required

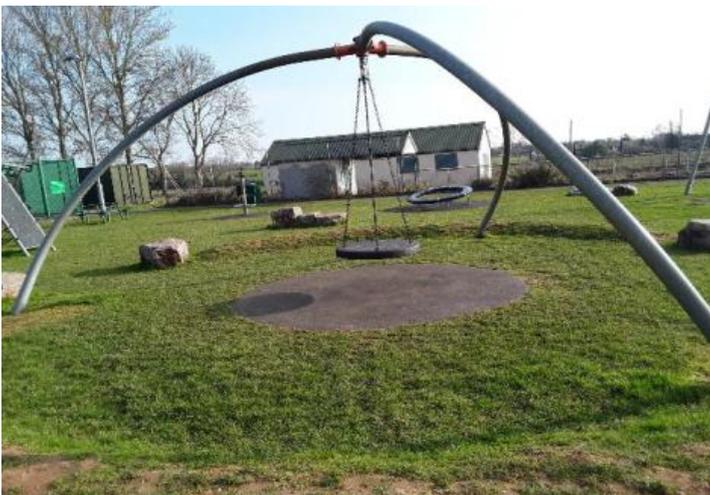
Item: Swings - Single Point Swing - Type 3
Manufacturer: Sutcliffe Play Limited

Risk Level: V - Very Low Risk
Surface: Mixed Surface

Finding: The chain openings are in excess of the 8.6mm as recommended by BS EN 1176

Action: Monitor - No remedial work recommended

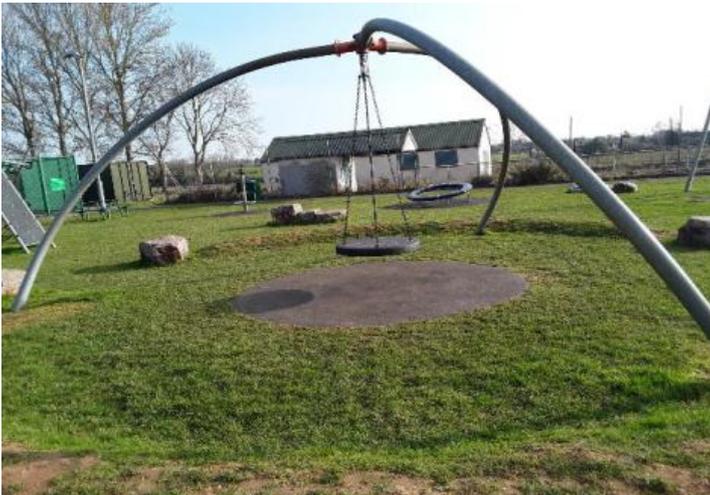
Item: Swings - Single Point Swing - Type 3
Manufacturer: Sutcliffe Play Limited

Risk Level: L - Low Risk
Surface: Mixed Surface

Finding: There is surface corrosion present on the item

Action: Consider treating the item

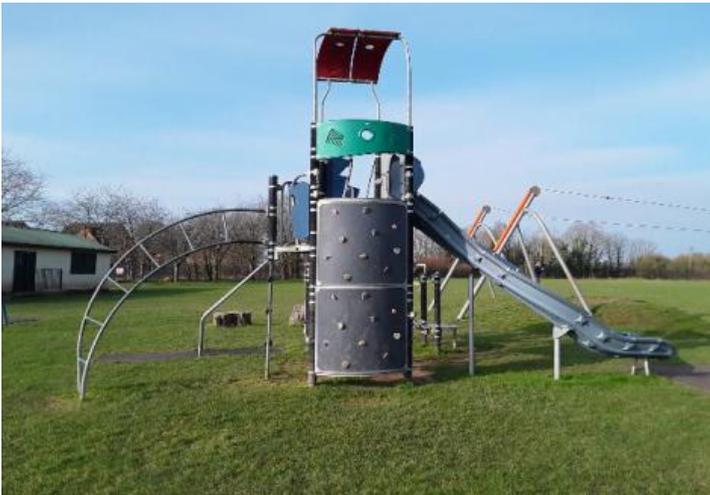
Item: Activity Equipment - Multi Play (Junior)
Manufacturer: Kompan Ltd

Risk Level: L - Low Risk
Surface: Mixed Surface

Finding: There is or are fixings missing on the item

Action: Replace all missing fixings

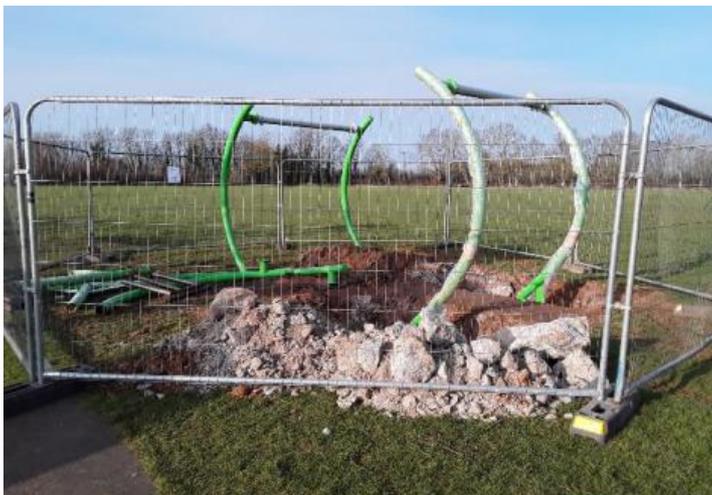
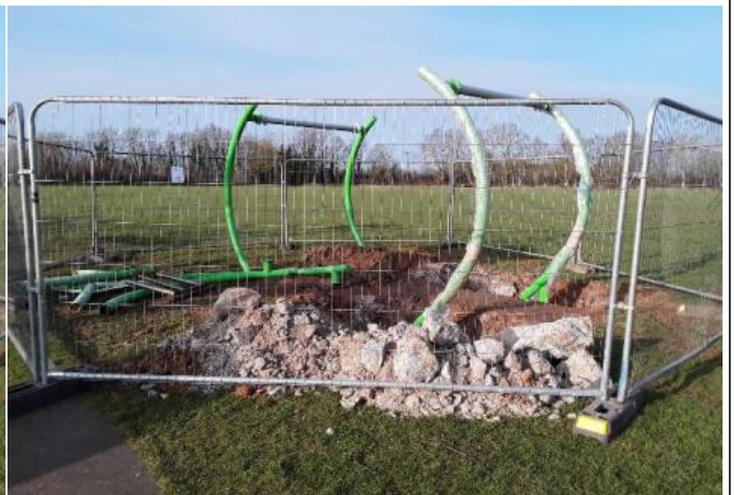
Item: Swings - Rope Swing
Manufacturer: Sutcliffe Play Limited

Risk Level: N - Risk Assessment not Undertaken
Surface: Grass Matrix Tiles

Finding: The item has been fenced off while being reinstated

Action: Ensure that the item is inspected prior to allowing public access

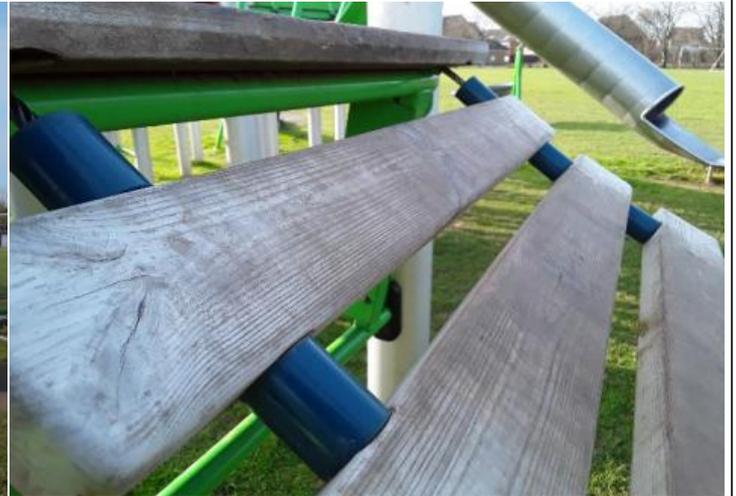
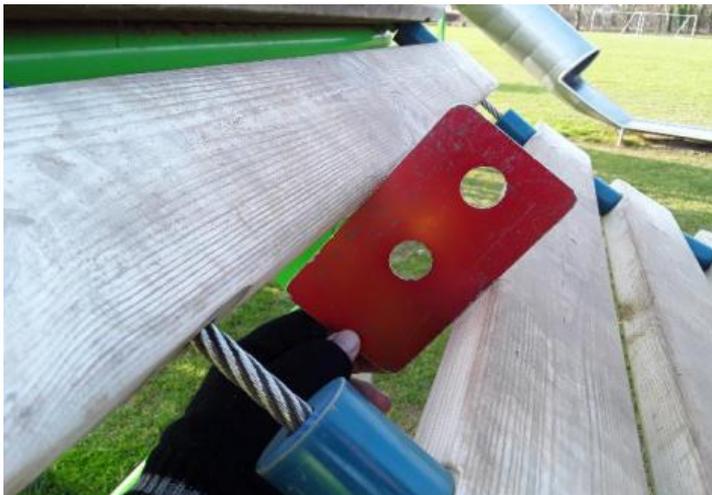
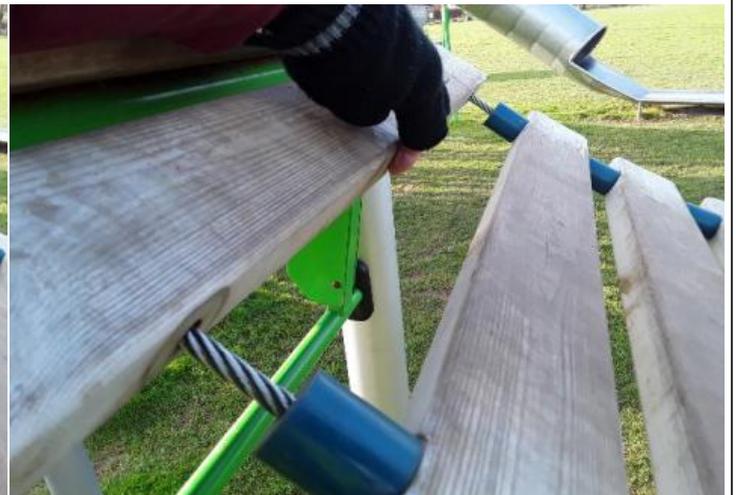
Item: Activity Equipment - Multi Play (Junior)
Manufacturer: Sutcliffe Play Limited

Risk Level: L - Low Risk
Surface: Grass Matrix Tiles

Finding: The bridge slats can be moved creating a potential head trap between the slats
Action: Secure the slats in position

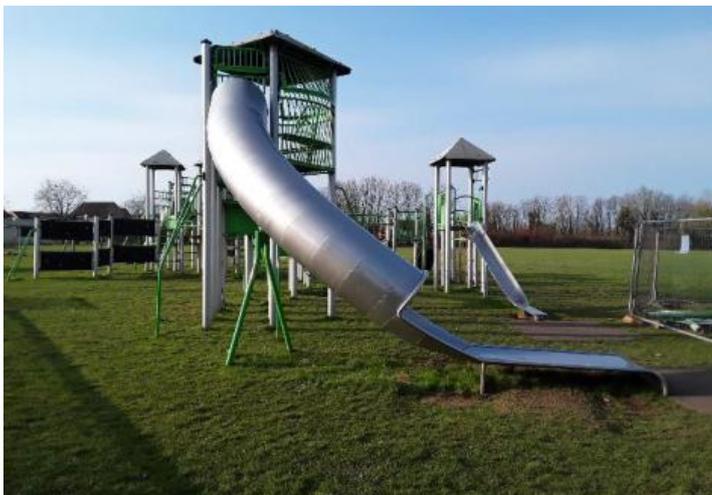
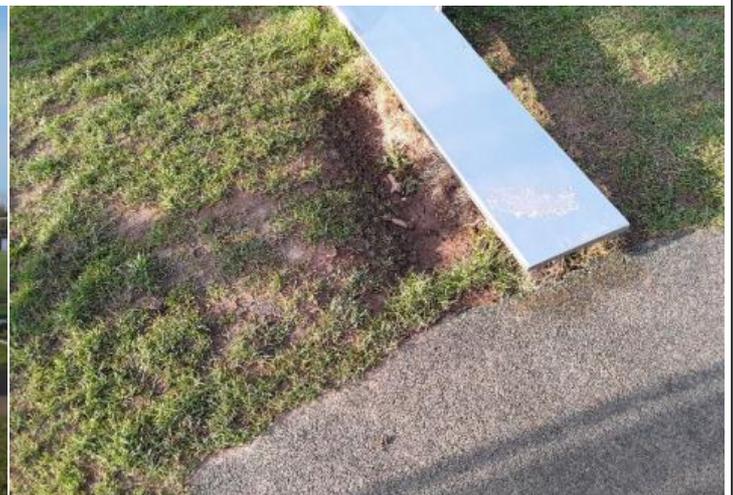
Item: Activity Equipment - Multi Play (Junior)
Manufacturer: Sutcliffe Play Limited

Risk Level: L - Low Risk
Surface: Grass Matrix Tiles

Finding: The area around the item has eroded and may become slippery

Action: Reinstate eroded area

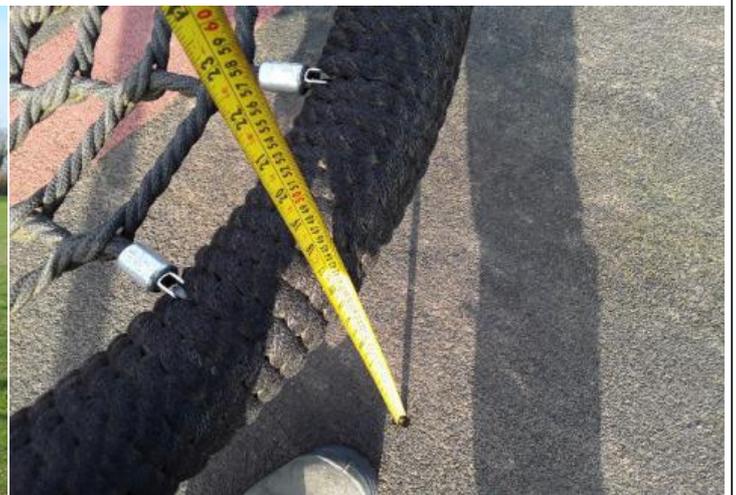
Item: Swings - Basket Swing - Type 1
Manufacturer: Not Identified

Risk Level: L - Low Risk
Surface: Wet Pour

Finding: The seat clearance from finished surface level to the underside of the seat is too low and does not meet the requirements of BS EN 1176 Part 2 (400mm minimum clearance required from rigid part of seat in most onerous position)

Action: Adjust seat clearance

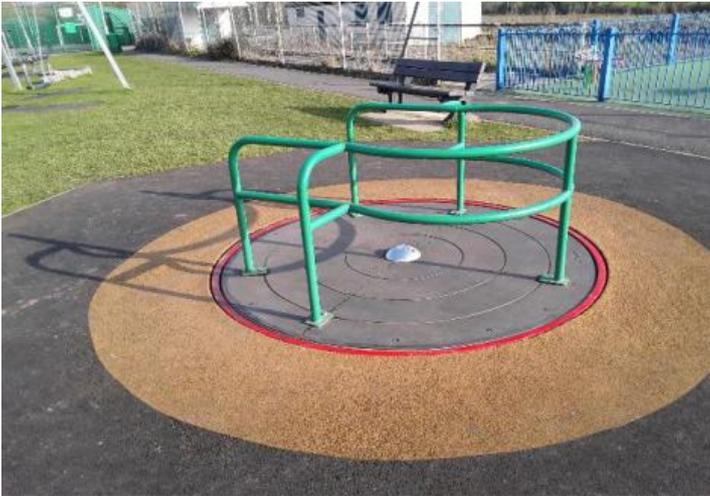
Item: Rotor Play - Roundabout
Manufacturer: Not Identified

Risk Level: L - Low Risk
Surface: Wet Pour

Finding: There is damage to the surface

Action: Repair the damaged areas of surfacing

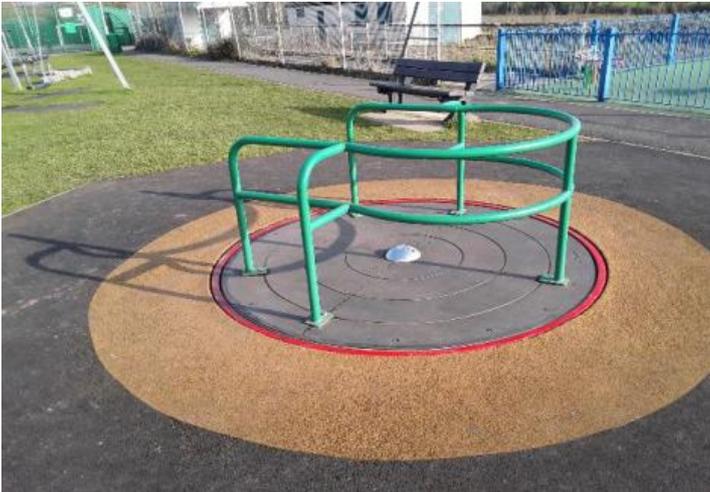
Item: Rotor Play - Roundabout
Manufacturer: Not Identified

Risk Level: V - Very Low Risk
Surface: Wet Pour

Finding: The surfacing dimensions are short and do not meet with the requirements of the current applicable standard

Action: Monitor - no remedial action recommended

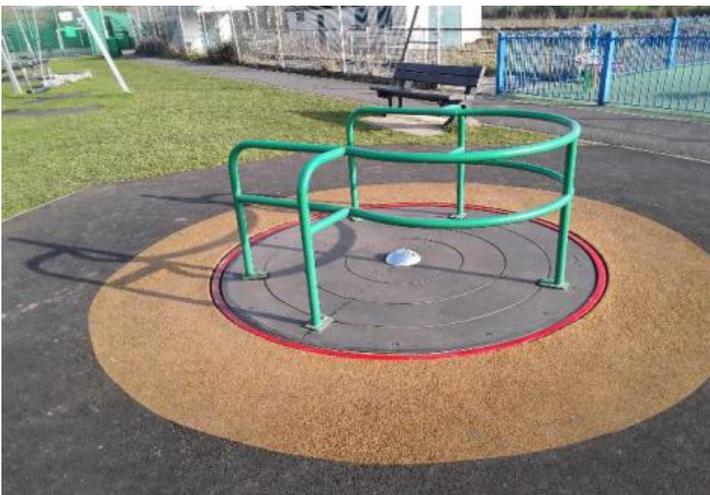
Item: Rotor Play - Roundabout
Manufacturer: Not Identified

Risk Level: L - Low Risk
Surface: Wet Pour

Finding: The bearing is worn / damaged and the item is not operating correctly **Action:** Repair / replace the bearing
